# **Durability of reinforced concrete beams repaired with various repair materials**

**Hamoud Ahmad Farhan Dehwah**

**MASTER OF SCIENCE**

**CIVIL ENGINEERING**

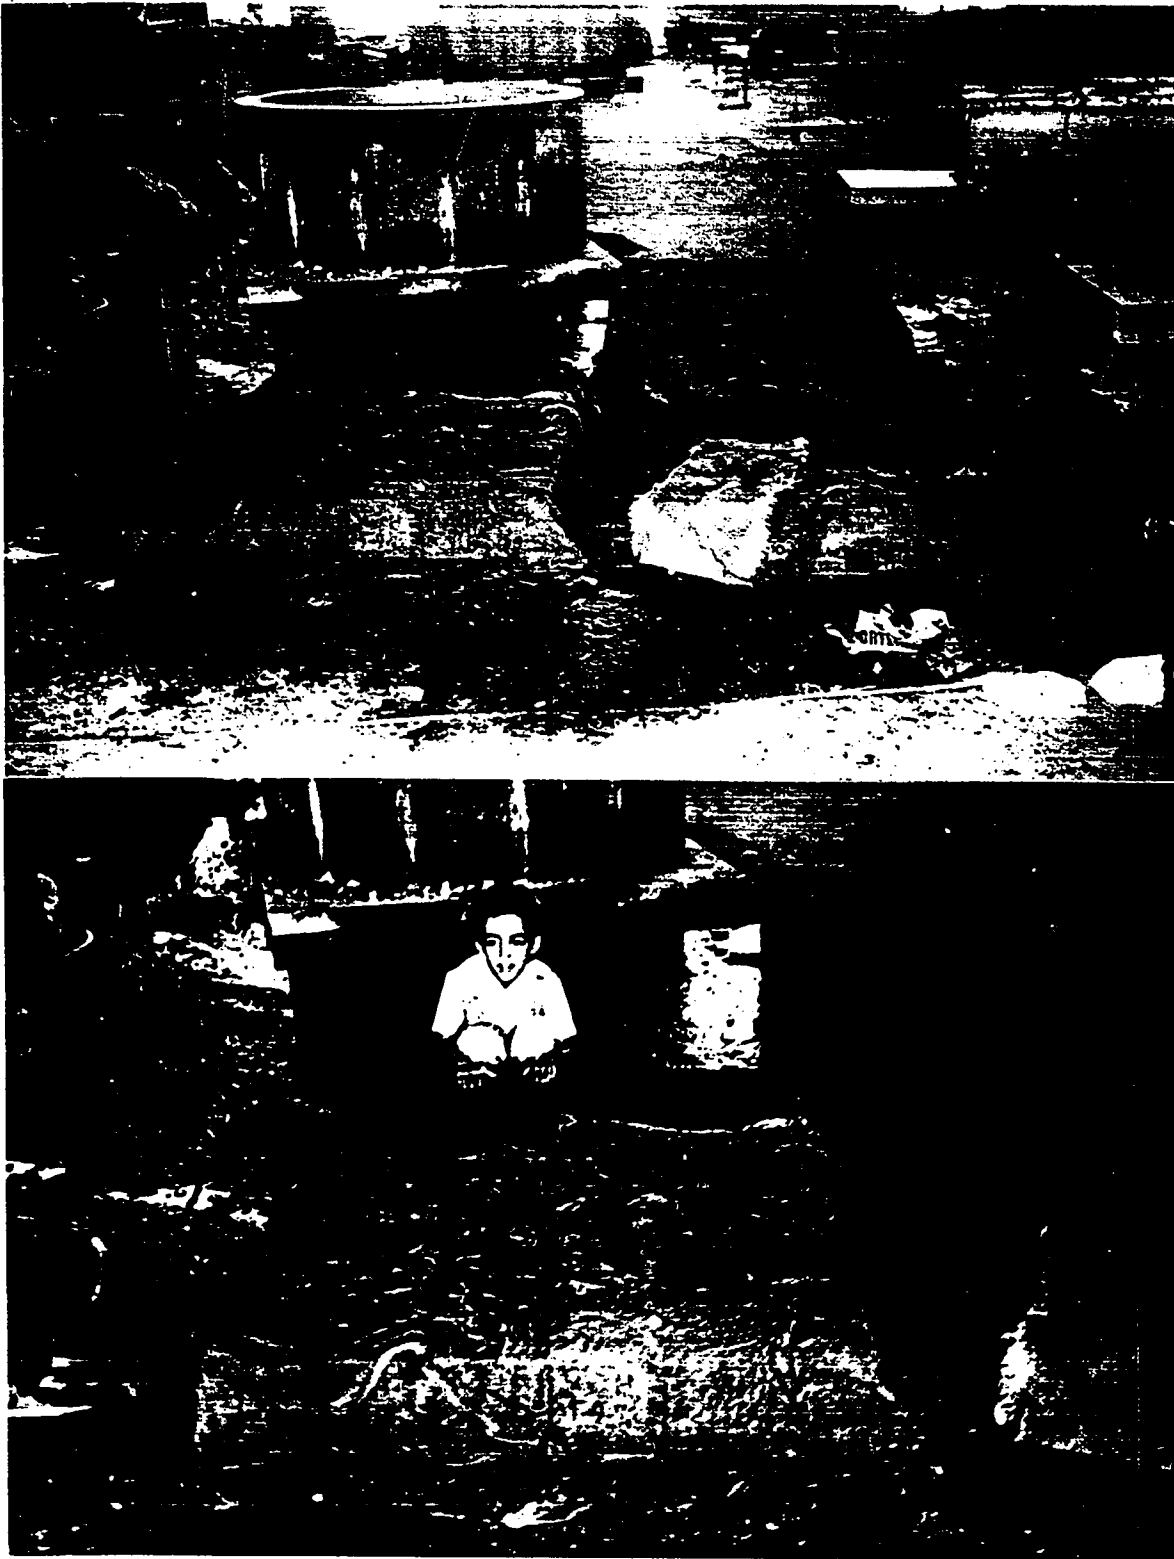
Plate 3.4 Reinforced Concrete Beams Cured Using Burlaps

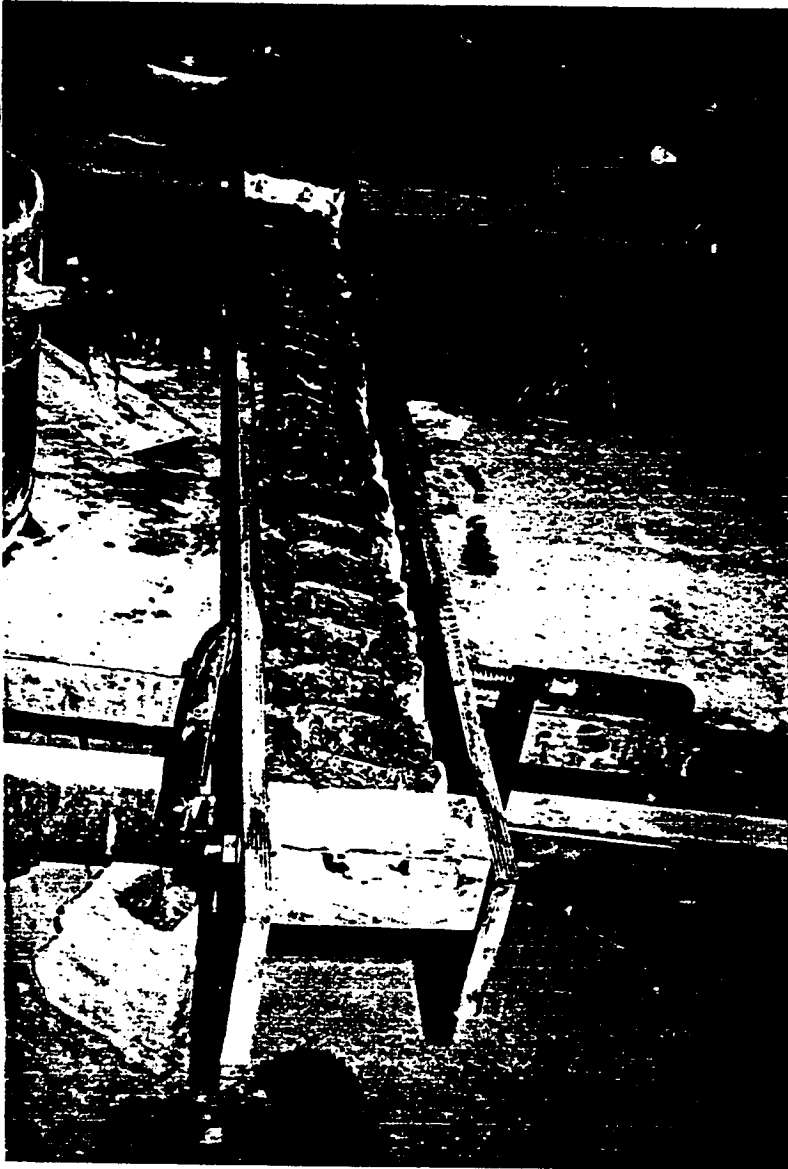
Plate 3.6 Bonding Agent Applied on the Chipped Surface.

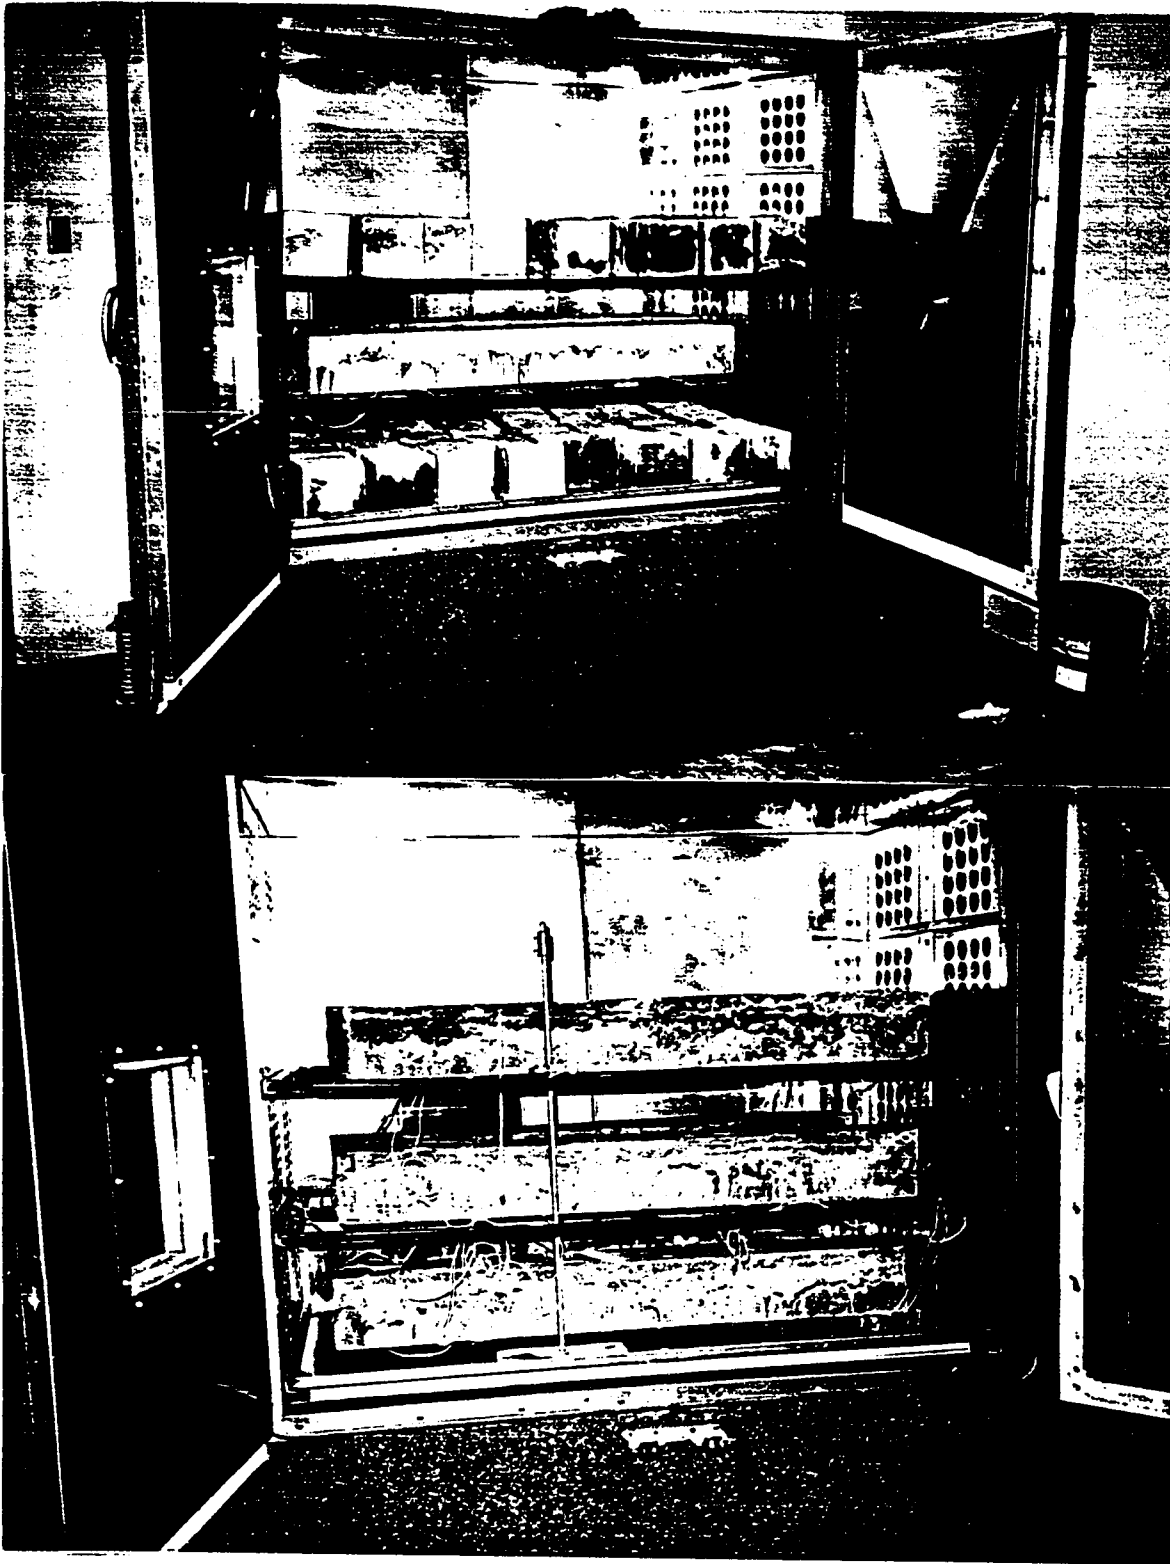
Plate 3.8 Beams and Cubes in the Oven for Heat-Cool Cycling

Three repaired beams from each repair category were subjected to heat-cool treatment in order to evaluate their performance in a simulated conditions of the Arabian Gulf environment. The heat-cool cycles were designed to represent daily and seasonal variations in the ambient temperatures in this part of the world. The beams were placed in an electrical oven as shown in Plate 3.8. The temperature was raised gradually till it reached a maximum temperature of 80°C. It took about 4 hours for the oven to attain this temperature. The oven was maintained at 80°C for two hours, and then the temperature was gradually decreased to room temperature in four hours. The oven was maintained at room temperature for two hours, before another heat-cycle was initiated. The repaired beams were subjected to 60 heat-cool cycles. The beams were then placed in 5% sodium chloride solution for corrosion monitoring.

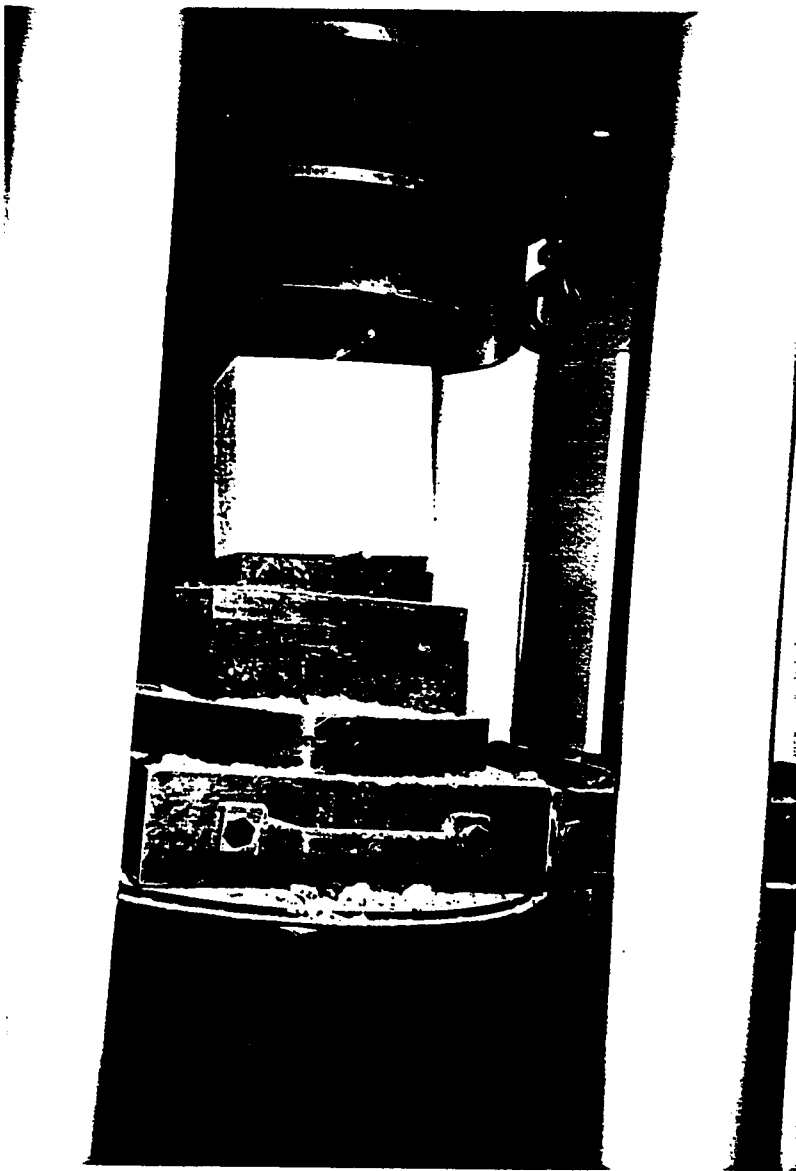
Plate 3.16      Splitting of Samples to Determine the Water Penetration Depth

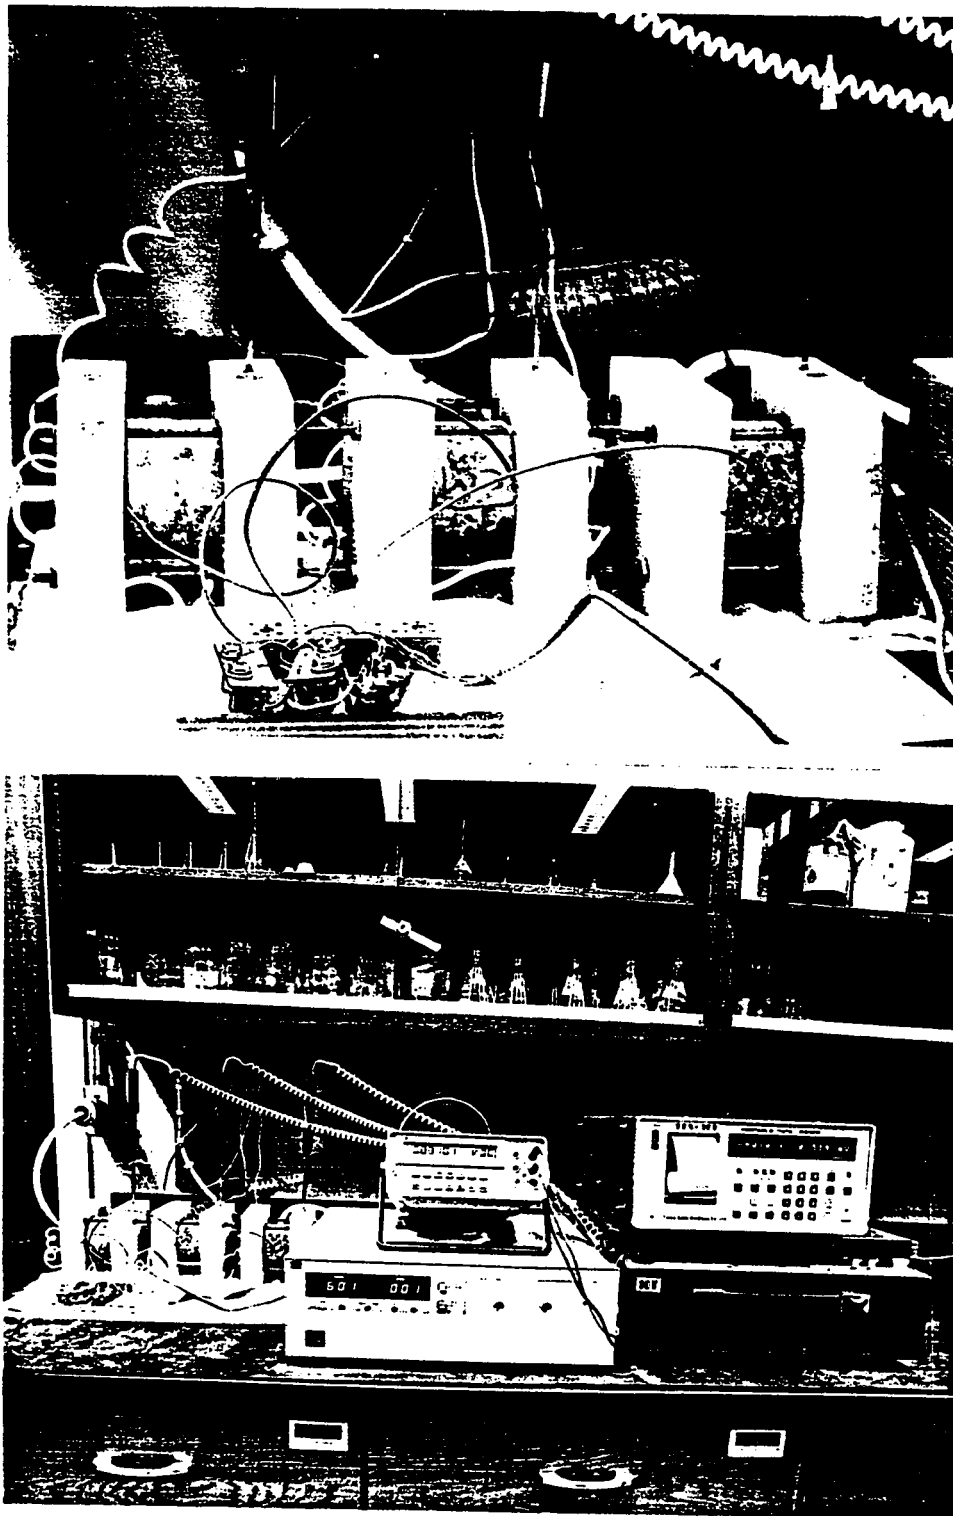
Plate 3.17 Chloride Permeability Test Set-up.

The current was plotted against time. The area under the curve is the total charge passed in Coloumbs (ampere-seconds). Higher value of the total charge indicates increased diffusion of chloride ions. Three samples from each group were tested. Plate 3.17 shows the experimental set-up and Figure 3.6 is a schematic representation of the chloride permeability test.
