Improving the performance of damaged FBECR in chloride-contaminated concrete

A Thesis Presented to the
DEANSHIP OF GRADUATE STUDIES

KING FAHD UNIVERSITY OF PETROLEUM & MINERALS

MARCH 2005

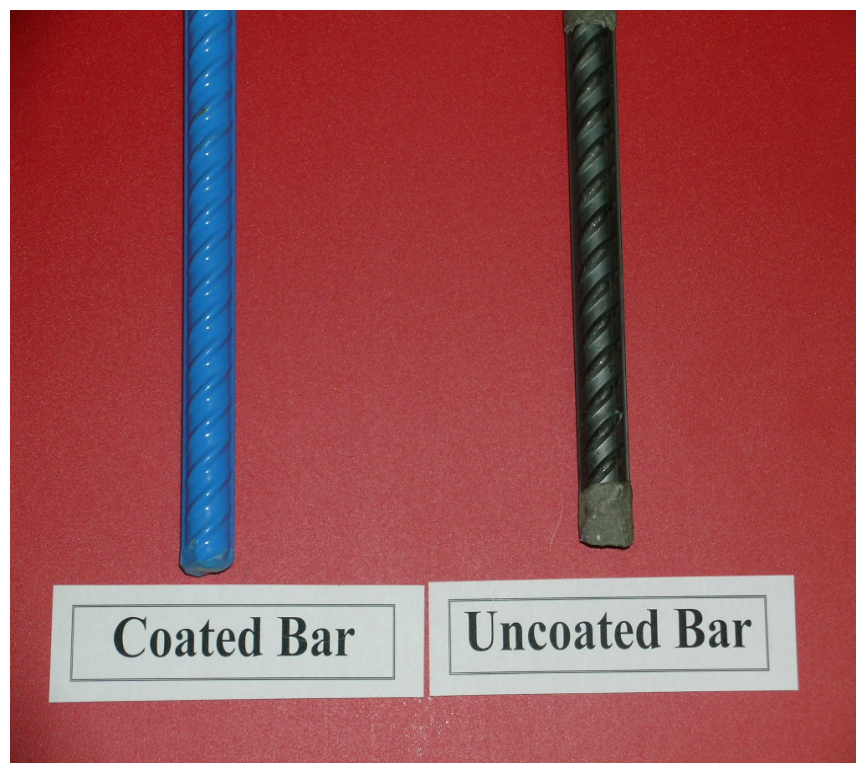
Plate 3.1: Coated and uncoated steel bars used in this study.

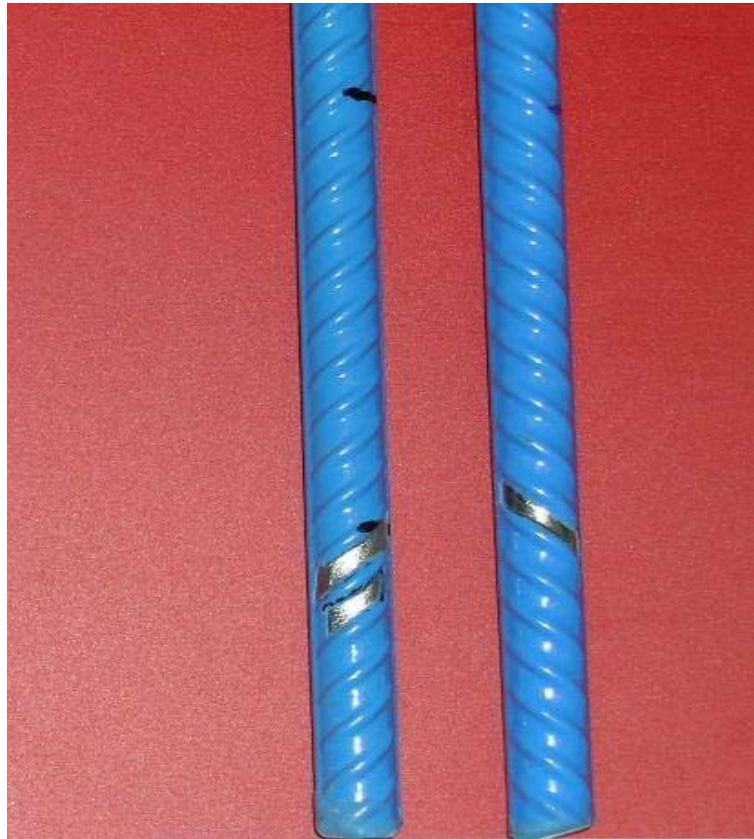
The prescribed levels of surface damages were achieved by intentionally damaging the coating till the steel surface was visible. This was done by using a scriber. Plate 3.2 shows fusion-bonded epoxy-coated steel bars with 3% and 1.5% surface damage.

Plate 3.2: Fusion-bonded epoxy-coated steel bars with 3% and 1.5% surface damage.

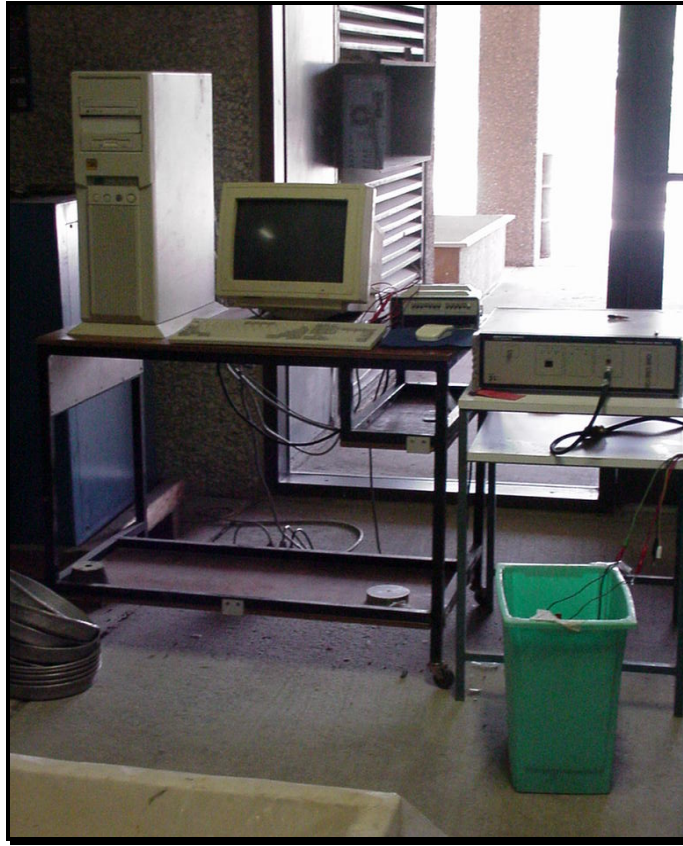
In this test, three electrodes were used to measure the resistance to polarization (R_p) using a Potentiostat\Galvanostat. The steel rod was connected to the working electrode terminal while a steel plate and a reference electrode were connected to the respective terminals of the potentiostat. The steel was polarized by applying a potential of ± 10 mV of the open circuit potential and the resulting current between the counter and the working electrodes was measured. The potentials were changed at a rate of 6 mV/min and the resulting current was measured. Figure 3.5 shows the general view of the experimental setup.

Figure 3.5: Experimental setup for corrosion current density measurements.

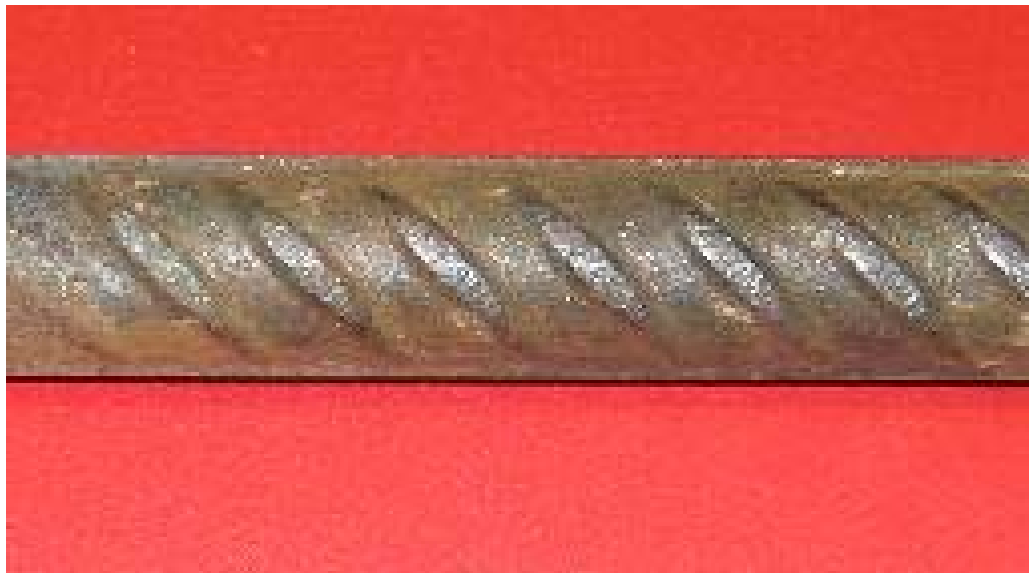
Figure 4.104: Steel Bar Retrieved from Plain Cement Concrete Specimen with 2% Chloride Concentration and Exposed to 48°C.

The plain and blended cement concrete specimens prepared with uncoated and FBEC steel bars with varying surface damages and chloride contaminations and exposed to varying temperatures were broken to retrieve the steel bars. The bars were then examined visually for the degree of corrosion. Figures 4.104 through 4.115 show the reinforcing steel bars retrieved from the concrete specimens while Tables 4.8 through 4.10 summarize the corrosion ratings.

Minor to moderate corrosion was noted on the FBEC steel bars with 3% damage in plain and fly ash cement concrete specimens with 2% chloride contamination exposed to 35°C and 48°C.

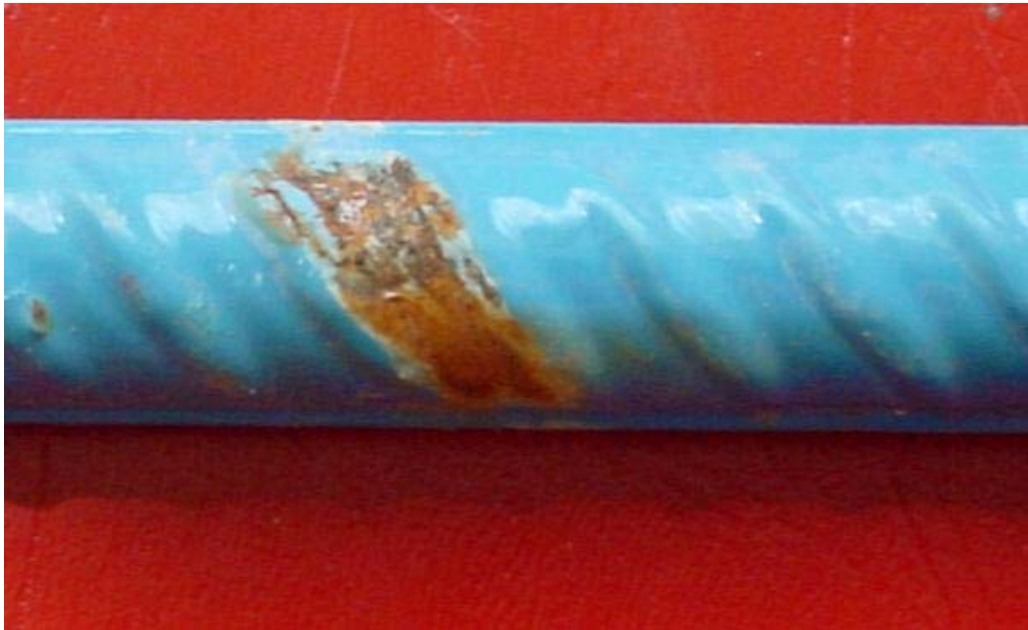
Figure 4.105: Epoxy Coated Bar with 3% Damage Retrieved from Plain Cement Concrete Specimen with 2% Chloride Concentration Exposed to 35°C.

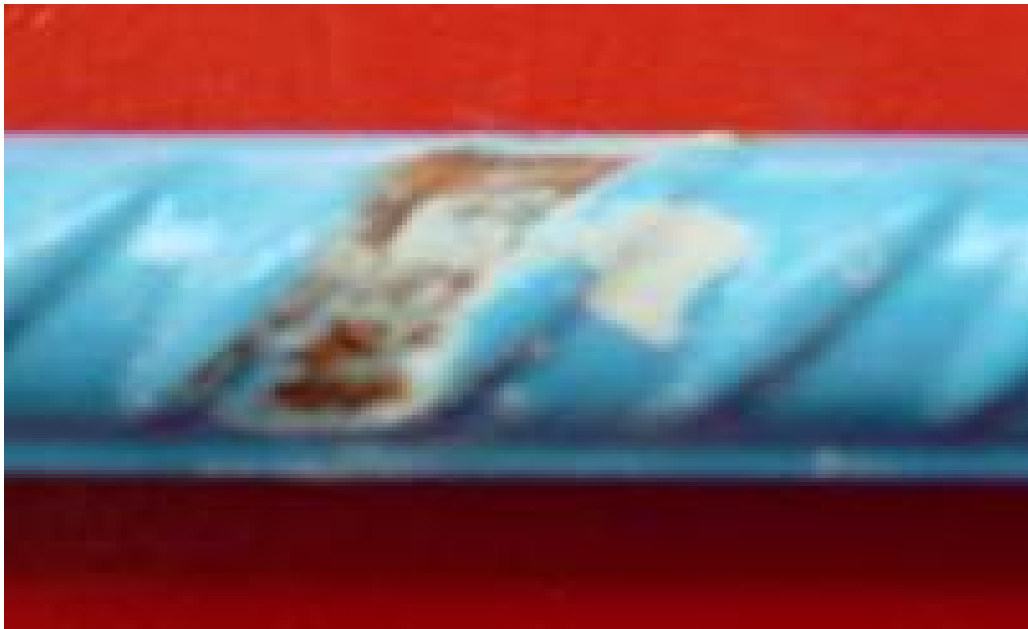
Figure 4.106: Epoxy Coated Bar with 1.5% Damage Retrieved from Plain Cement Concrete Specimen with 1% Chloride Concentration Exposed to 35°C.

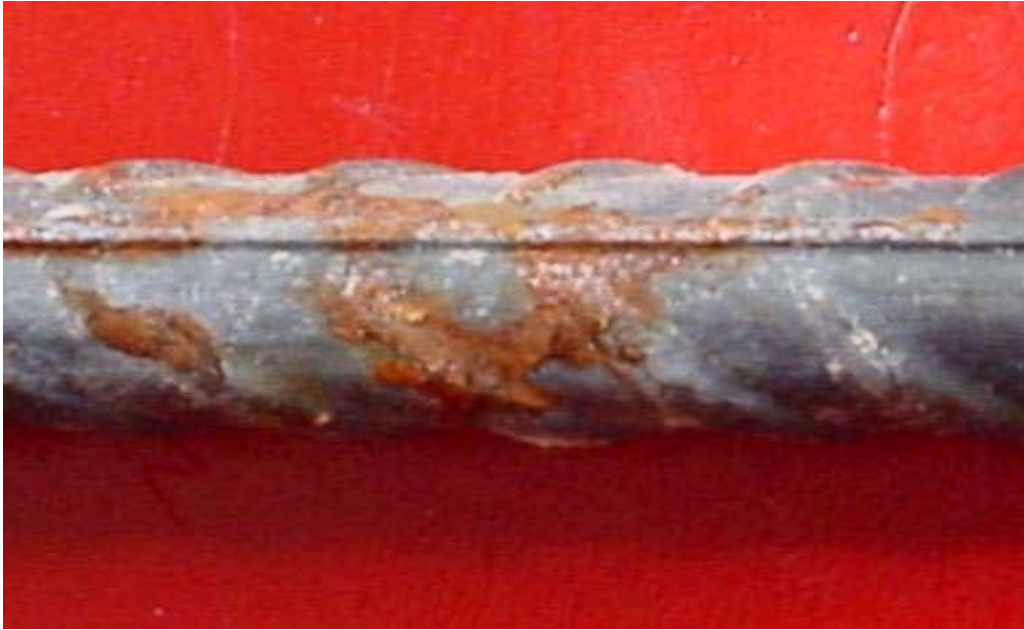
Figure 4.107: Uncoated Bars retrieved from Plain Cement Concrete Specimen with 2% Chloride Concentration Exposed to 35°C.

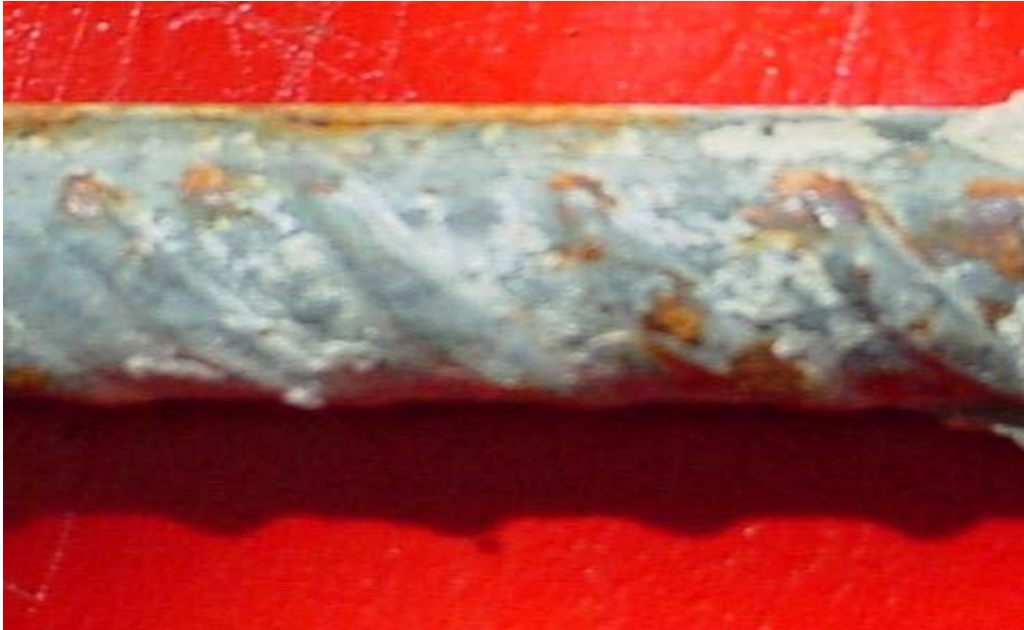
Figure 4.109: Uncoated Steel Bar retrieved from Fly Ash Cement Concrete Specimen with 2% Chloride Concentration Exposed to 48°C.

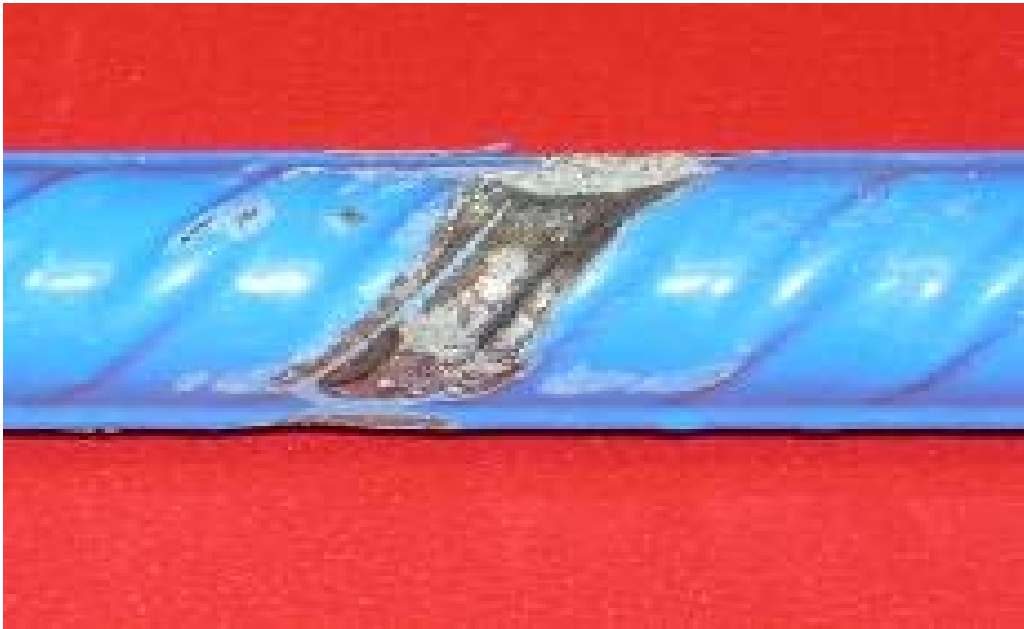
Figure 4.110: Epoxy Coated Bar with 1.5% Damage Retrieved from Blast Furnace Slag Cement Concrete Specimen with 1% Chloride Concentration Exposed to 23°C.

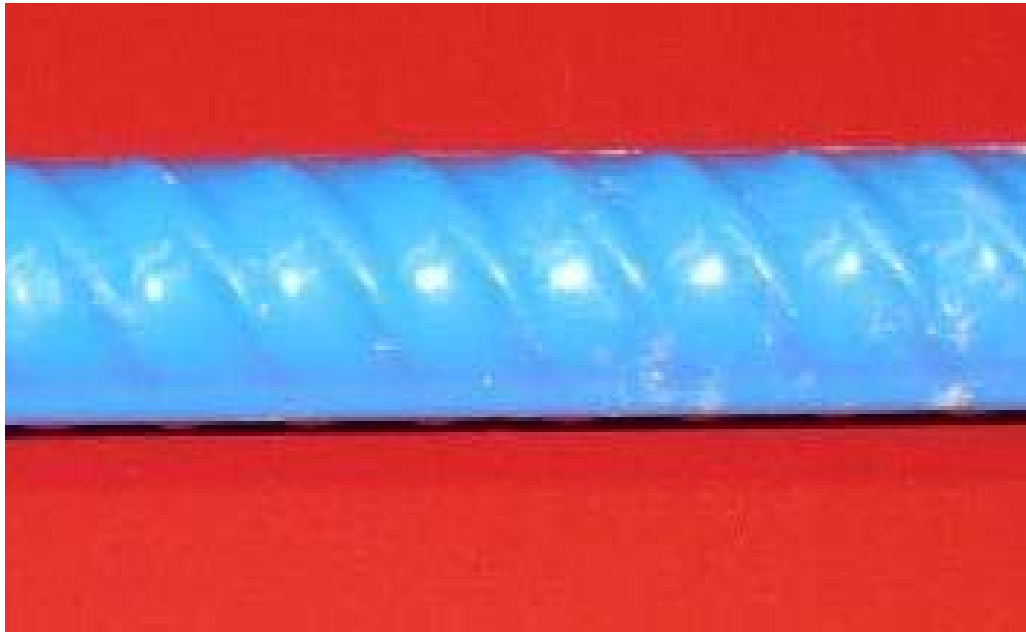
Figure 4.111: Epoxy Coated Bar retrieved from Silica Fume Cement Concrete Specimen with 2% Chloride Concentration Exposed to 48°C.

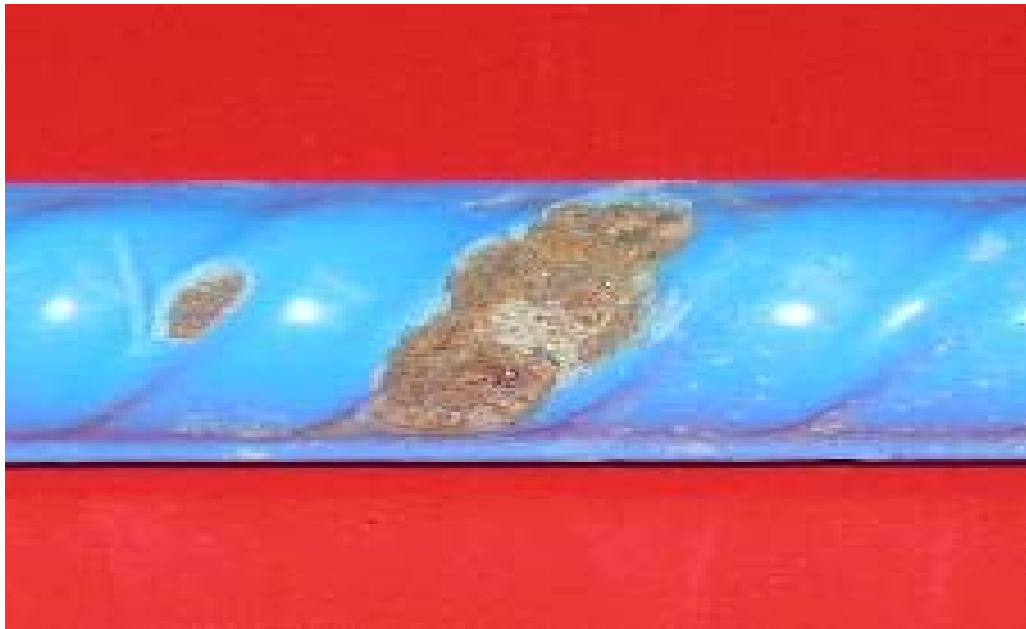
Figure 4.112: Epoxy Coated Bar with 3% Damage Retrieved from Plain Cement Concrete Specimen with 1% Chloride Concentration Exposed to 48°C.

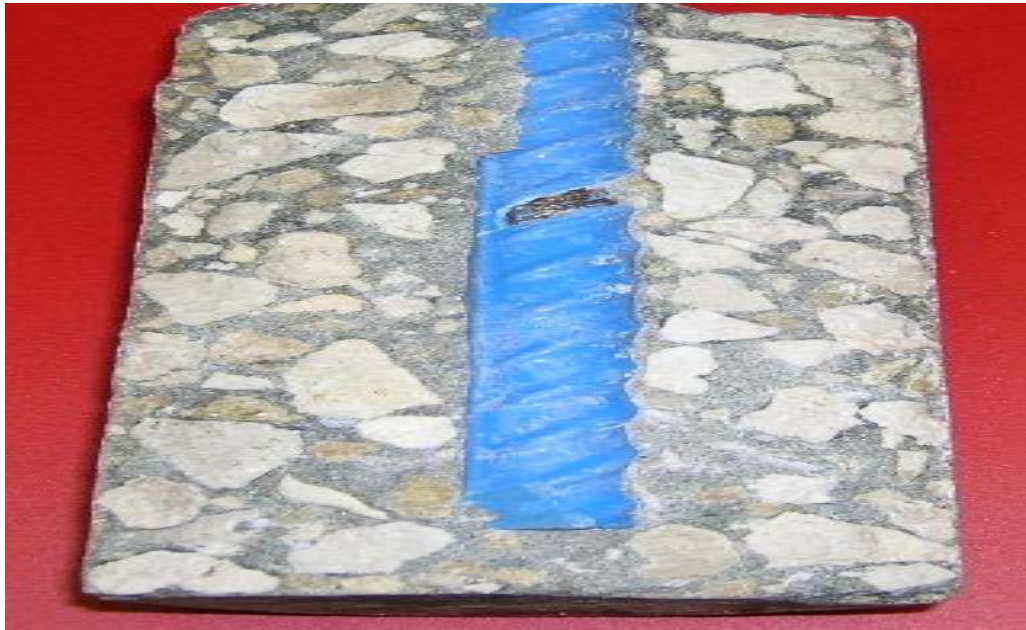
Figure 4.113: Epoxy Coated Bar with 3% Damage Retrieved from Plain Cement Concrete Specimen with 1% Chloride Concentration Exposed to Room Temperature.

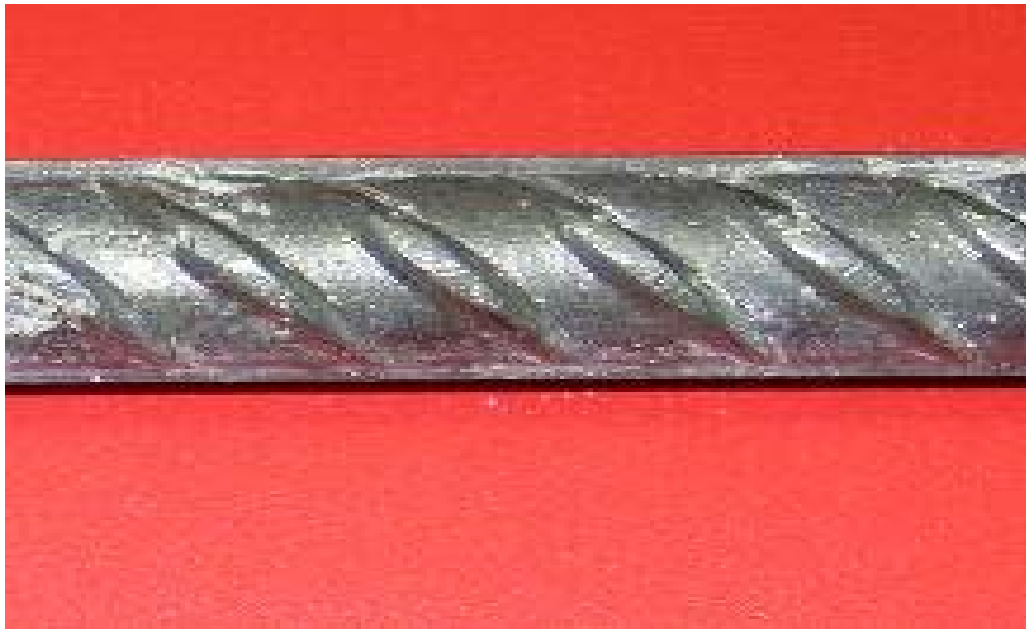
Figure 4.114: Uncoated Steel Bar Retrieved from Silica Fume Cement Concrete Specimen with 2% Chloride Concentration Exposed to 48°C.

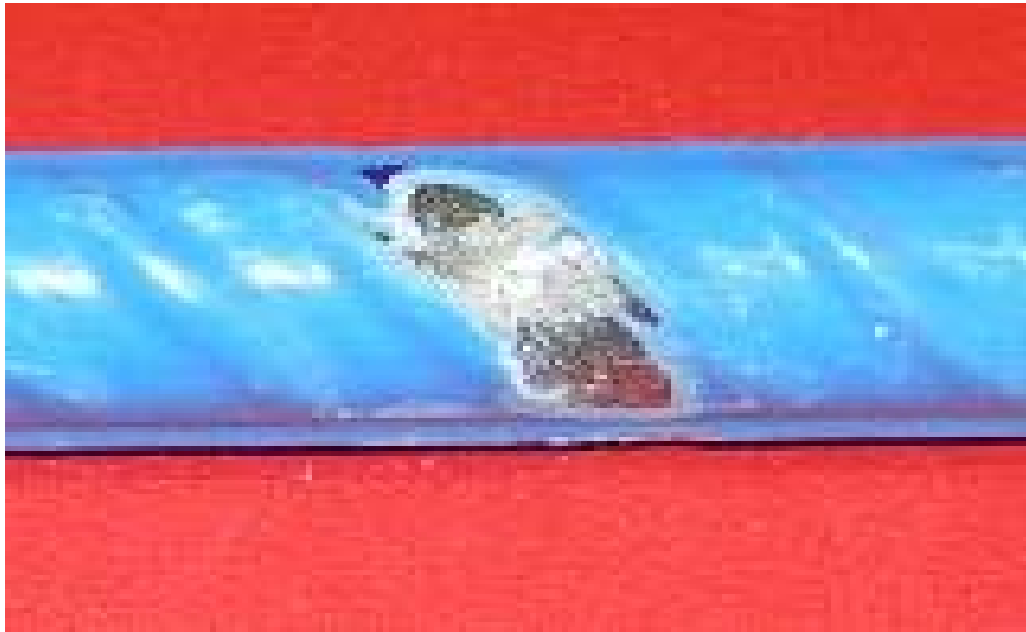
Figure 4.115: Epoxy Coated Bar with 3% Damage Retrieved from Silica Fume Cement Concrete Specimen with 1% Chloride Concentration Exposed to 23°C.
