An Investigation of corrosion of steel reinforcement in concrete in the Eastern Province of Saudi Arabia

A Thesis Presented to the

KING FAHD UNIVERSITY OF PETROLEUM & MINERALS

February, 1981

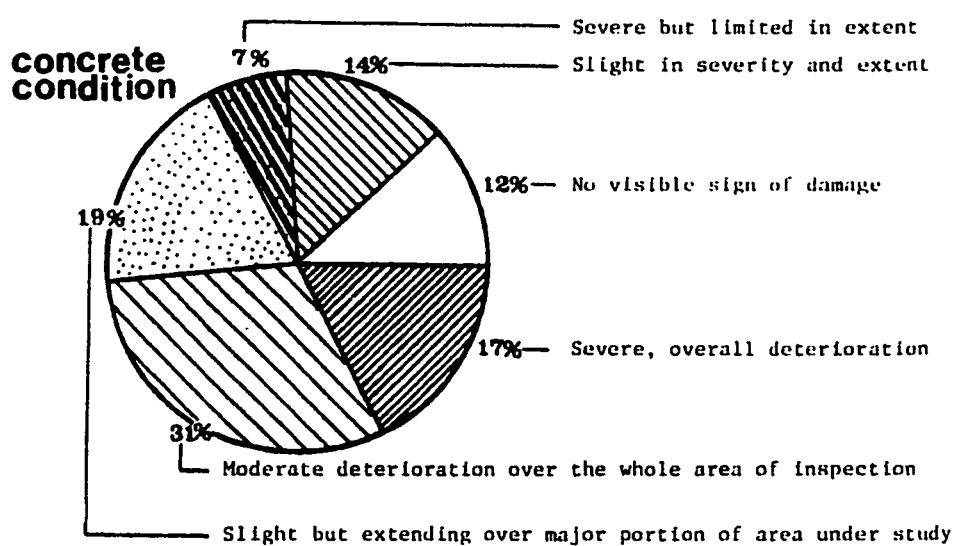
Fig. 1.1 : Classification of Condition of 168 Observations

The commonly occurring distress conditions observed during the condition surveys were : reinforcement corrosion, concrete spalling, cracking and surface mortar deterioration.

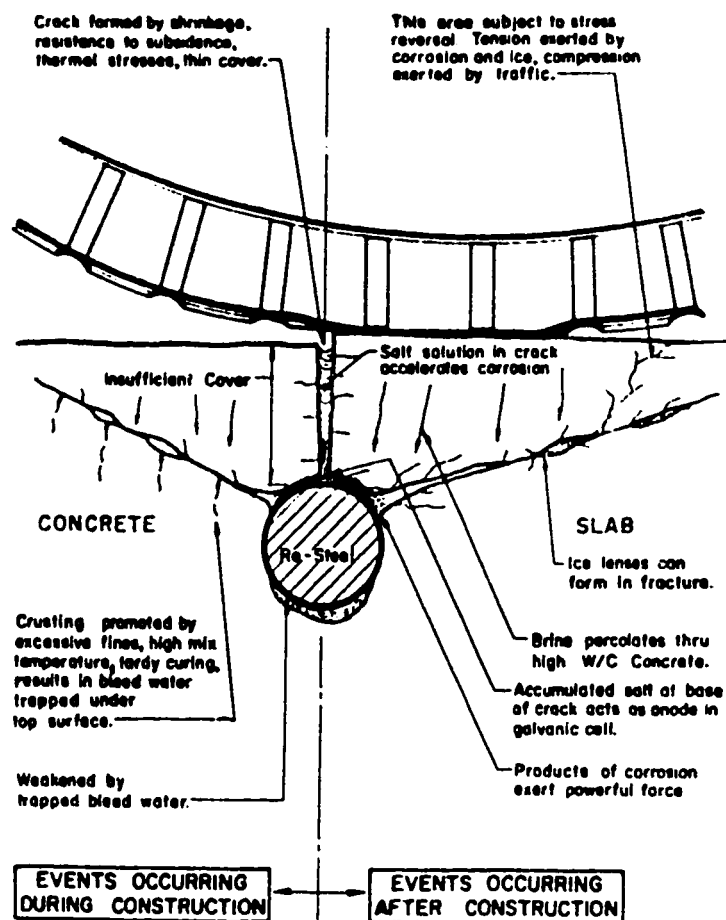
Fig. 1.2 : Corrosion of Bridge Deck Caused by Subsidence Cracks and Deicing Salts

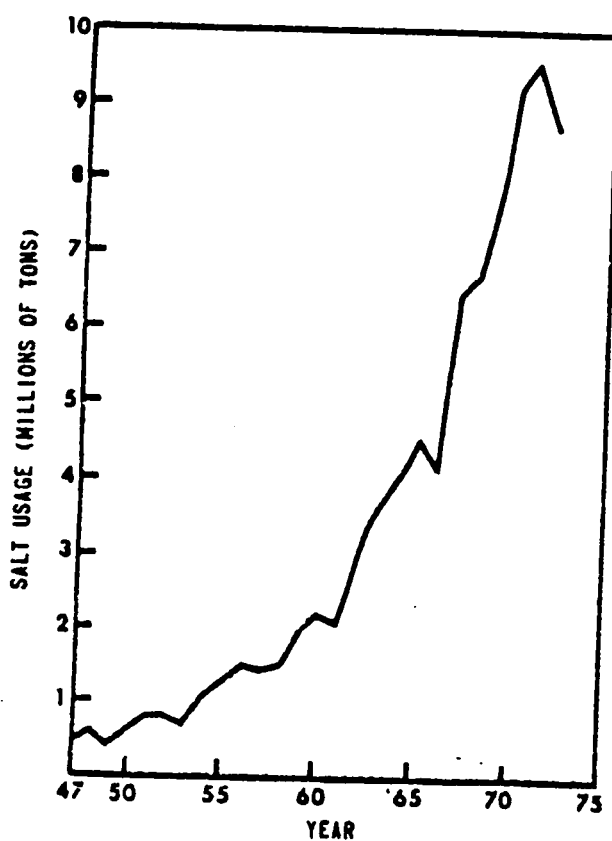
Fig. 1.3 : Increased Use of De-icing Salts Causing Bridge Deck Problem

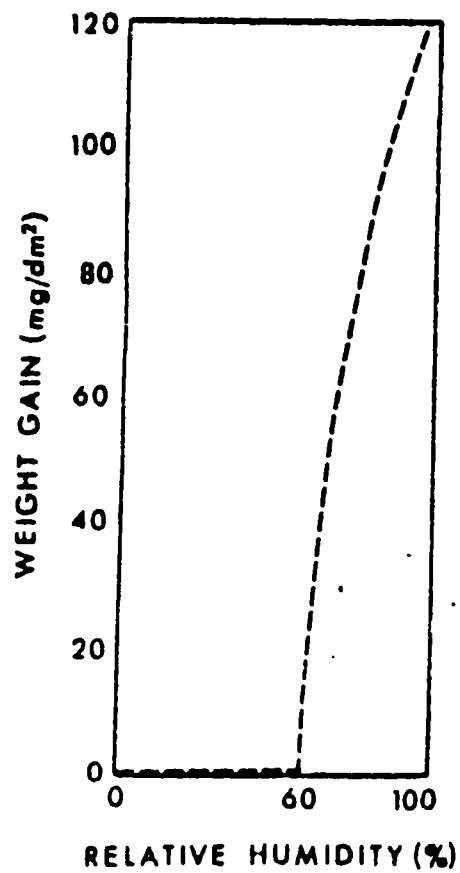
Fig.1.7 : Corrosion of iron in air containing 0.01% SO_2 , showing critical relative humidity

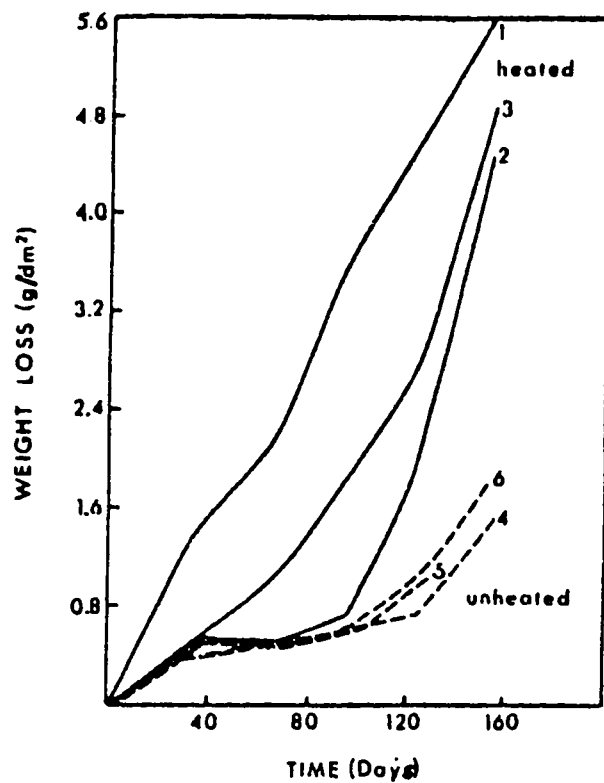
Fig.1.8 : Comparative corrosion rates of crevice specimens attached to vehicles stored in heated garages vs unheated garages

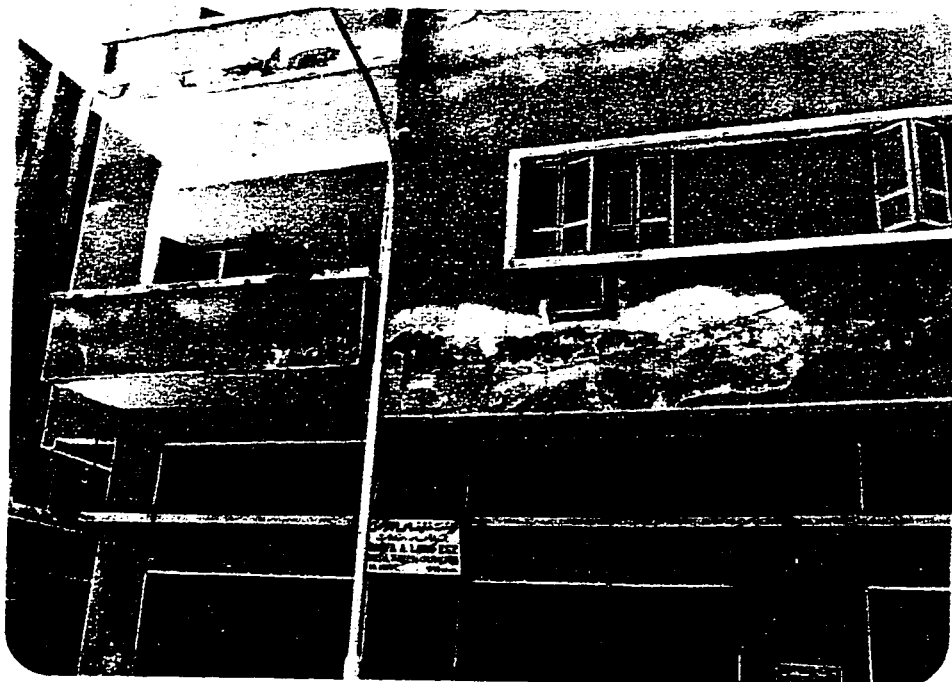
Plate 1.2 : Concrete deterioration due to sulphate attack and salt weathering

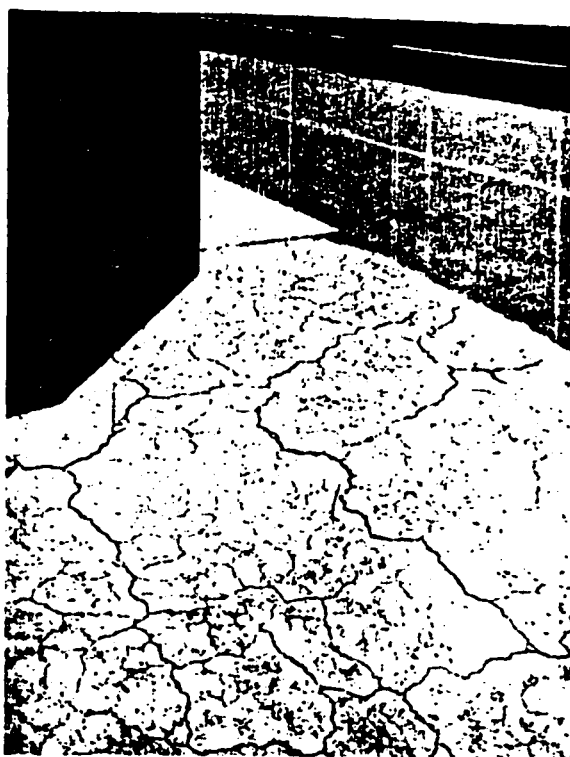
Plate 1.4 : Concrete cracking due to alkali-silica reaction

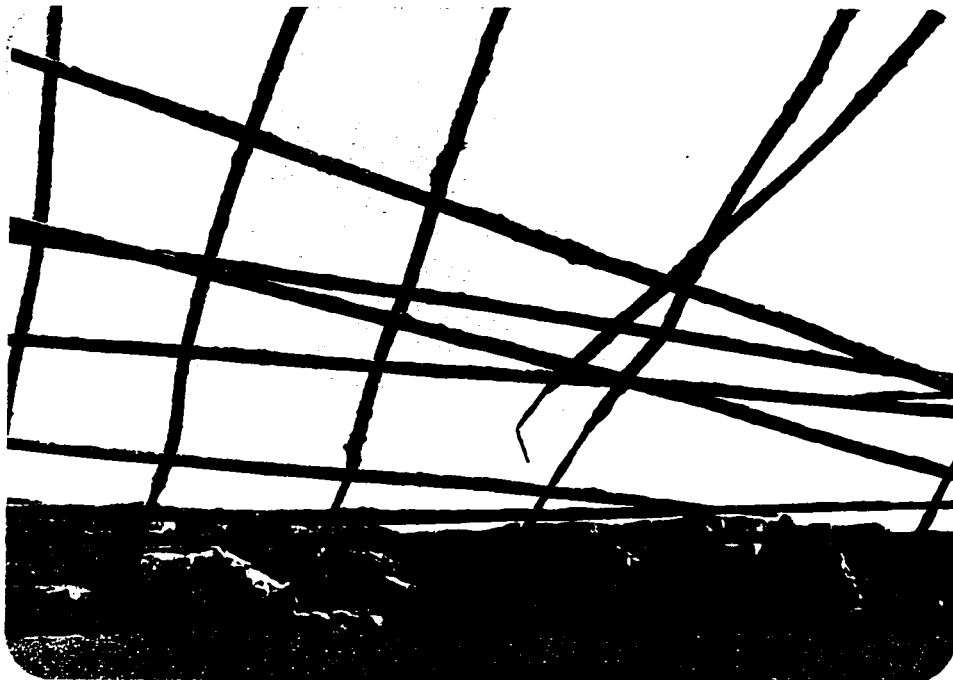
Plate 1.6 : Corrosion pitting on rebars

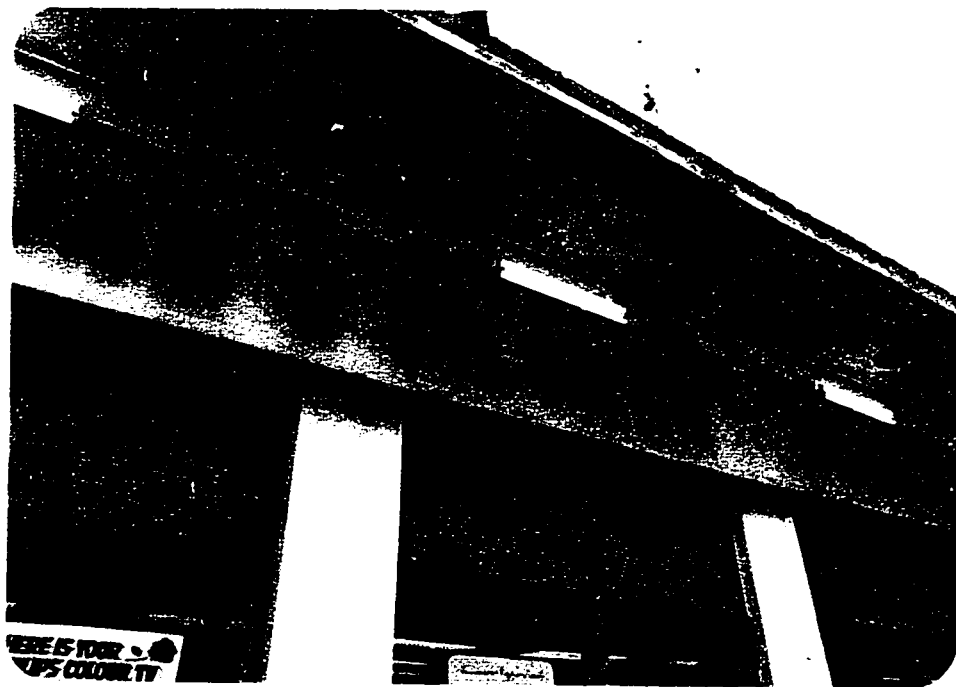
Plate 1.11 : Illustration of moderate deterioration over the
whole area of inspection (Classification 4)

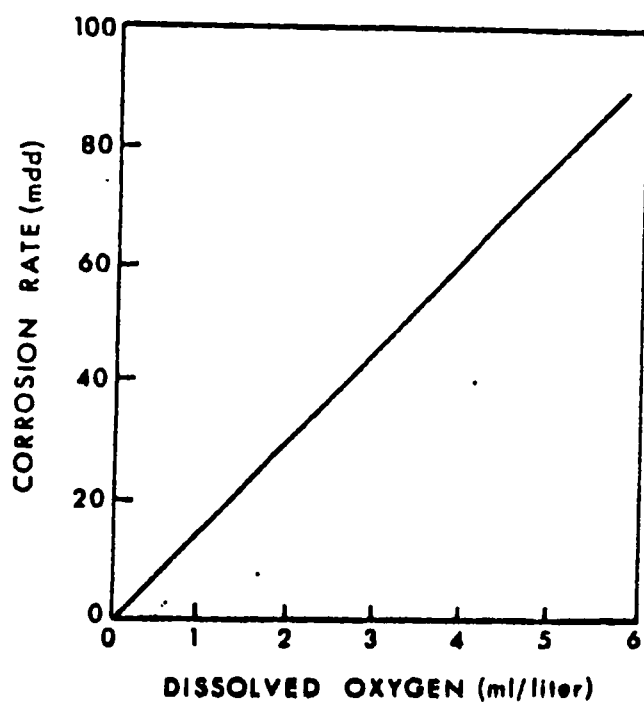
Fig. 2.6 : Effect of oxygen concentration on corrosion of mild steel

Dissolved oxygen in solutions is another factor that has a very definite effect on corrosion rates⁵⁸. In nearly neutral solutions, as in many natural waters, the concentration of dissolved oxygen is the controlling factor that determines corrosion rates. This fact is demonstrated⁵⁹ in Figure 2.6 which shows the effect of dissolved oxygen concentration on the corrosion of mild steel in slowly moving water containing 165 ppm CaCl_2 . The influence of dissolved oxygen on the corrosion process is illustrated by the qualitative curves shown in Figure 2.7. These curves

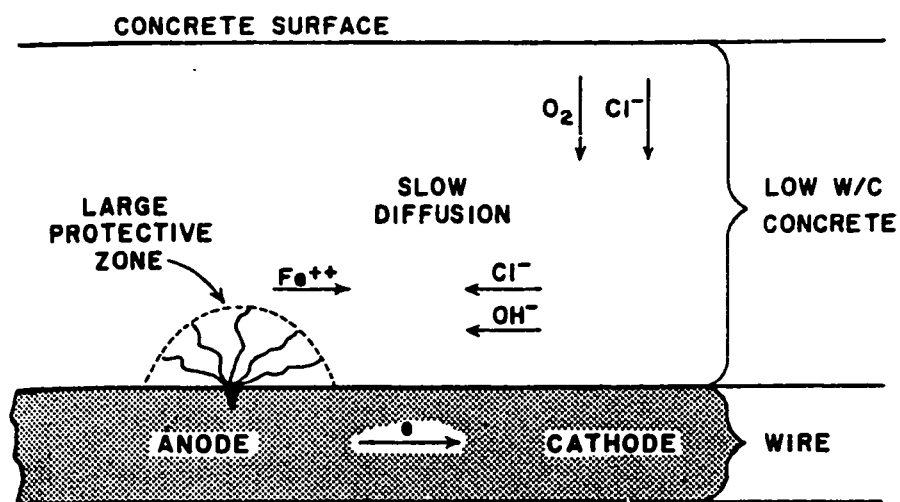
Fig 2.8 Schematic representation of corrosion in concrete of low water-cement ratio and well cured

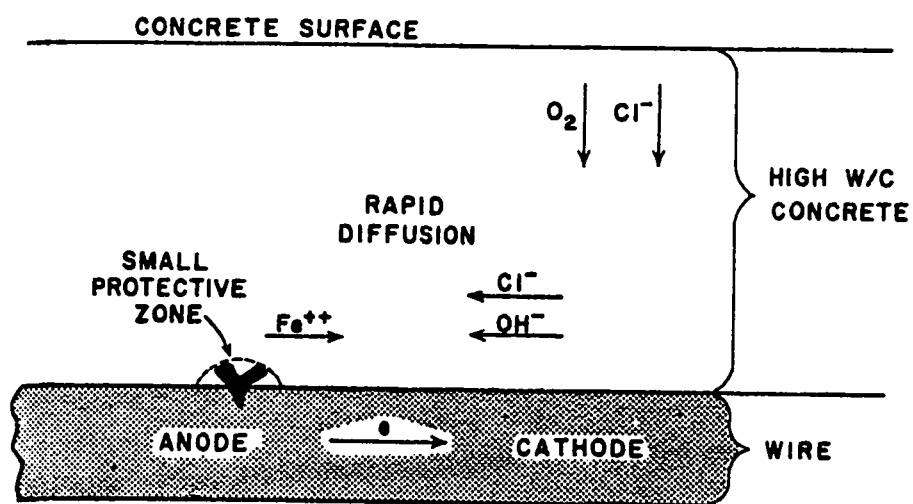
Fig. 2.9 : Schematic representation of corrosion in concrete of high water-cement ratio and poorly cured

Figure 2.9 represents the opposite model - concrete of high w/c ratio, poor compaction and inadequate curing. Because of the porous nature of concrete, the destructive materials, chloride, oxygen, water and carbon dioxide can diffuse rapidly towards the corrosion site. Since the capillary pores are large in size and numerous the "postulated protective zone" is significantly reduced.

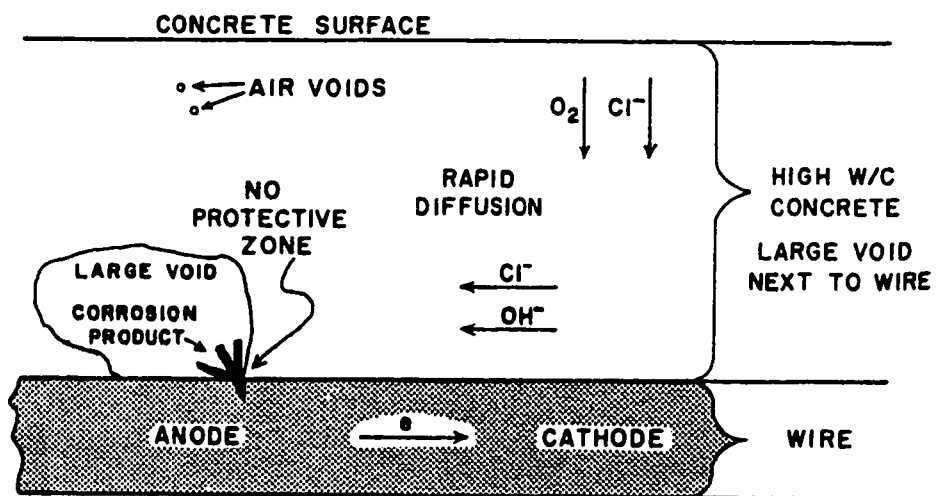
Fig. 2.10 : Schematic representation of corrosion in concrete of high water-cement ratio and with air pocket on steel

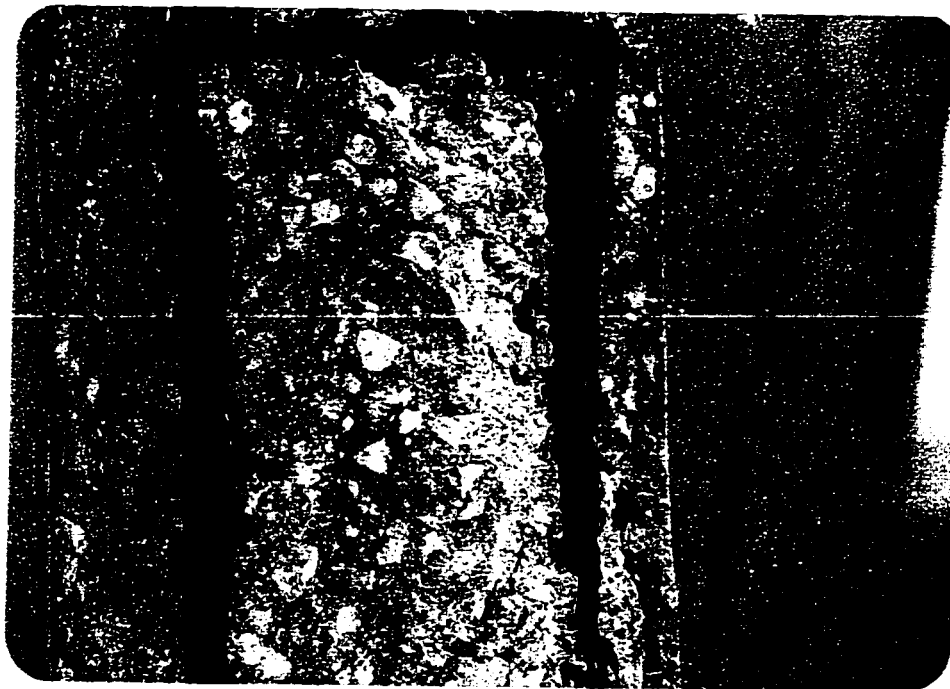
Plate 2.5 : Cracks developed along corroded steel reinforcement

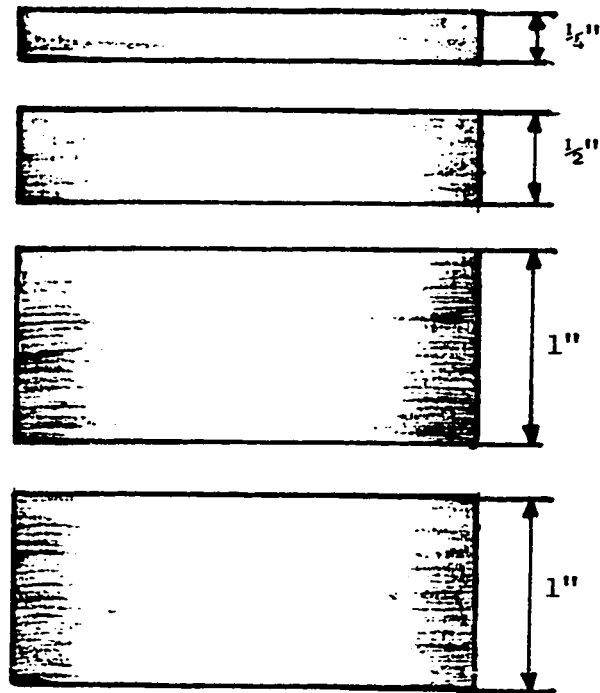
Fig.3.1 : Schematic diagram shows slices for chloride penetration test

subjected to an intermittent splash of salt water. A core was sliced obtaining $\frac{1}{4}$ inch, $\frac{1}{2}$ inch and 1 inch slices in the manner shown in Figure 3.1. Mortar was removed from the faces of these slices and subjected to chloride determination in the manner explained in section 3.6. These determinations when plotted against the depth of the core provided the chloride migration data in cracked and uncracked concrete samples.

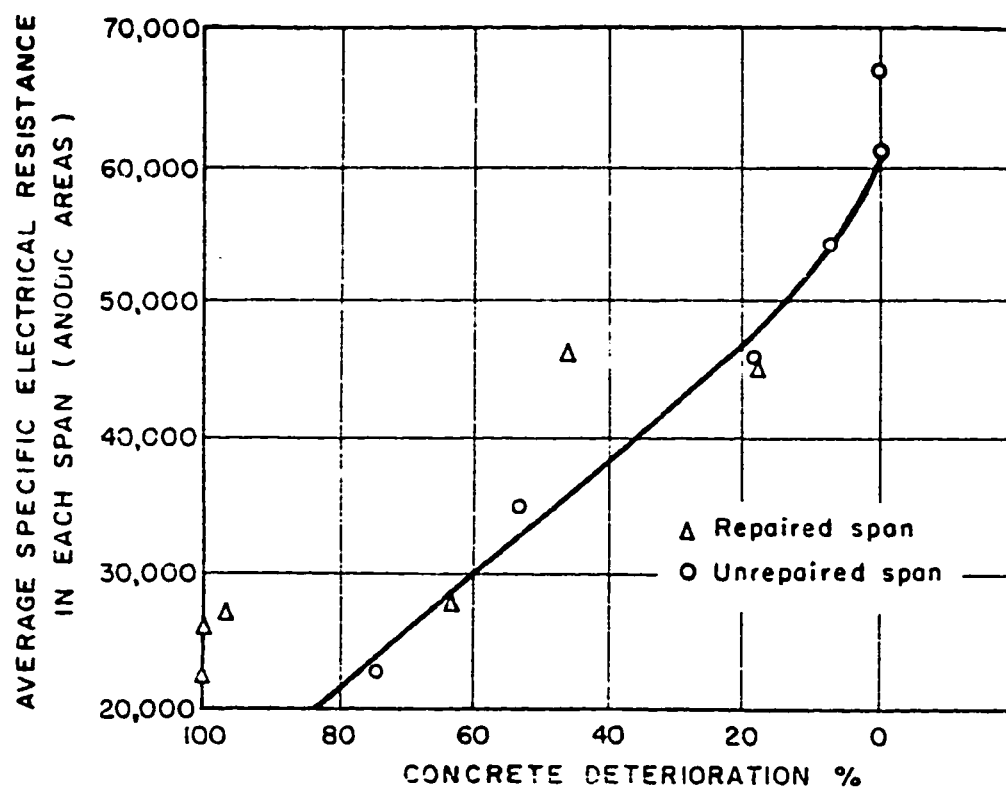
Fig. 4.5 : Specific electrical resistance against concrete deterioration

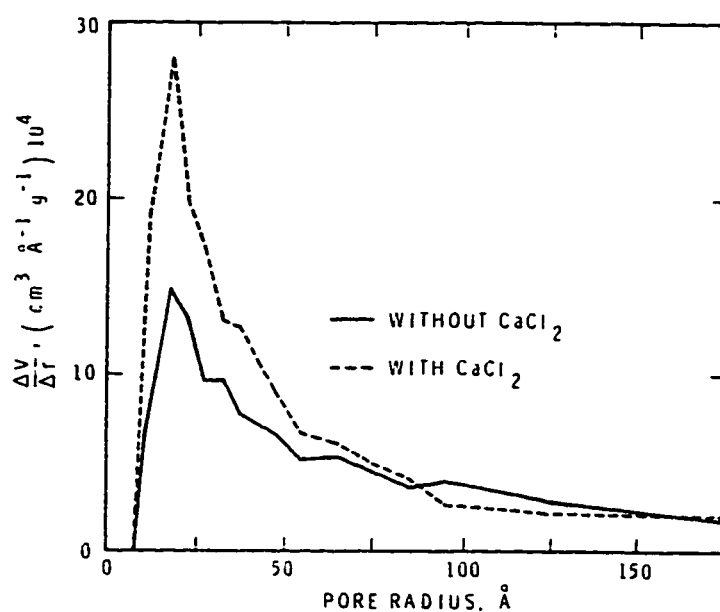
Fig. 4.6 : Pore-size distribution curves for portland cement paste hydrated for 7 days.

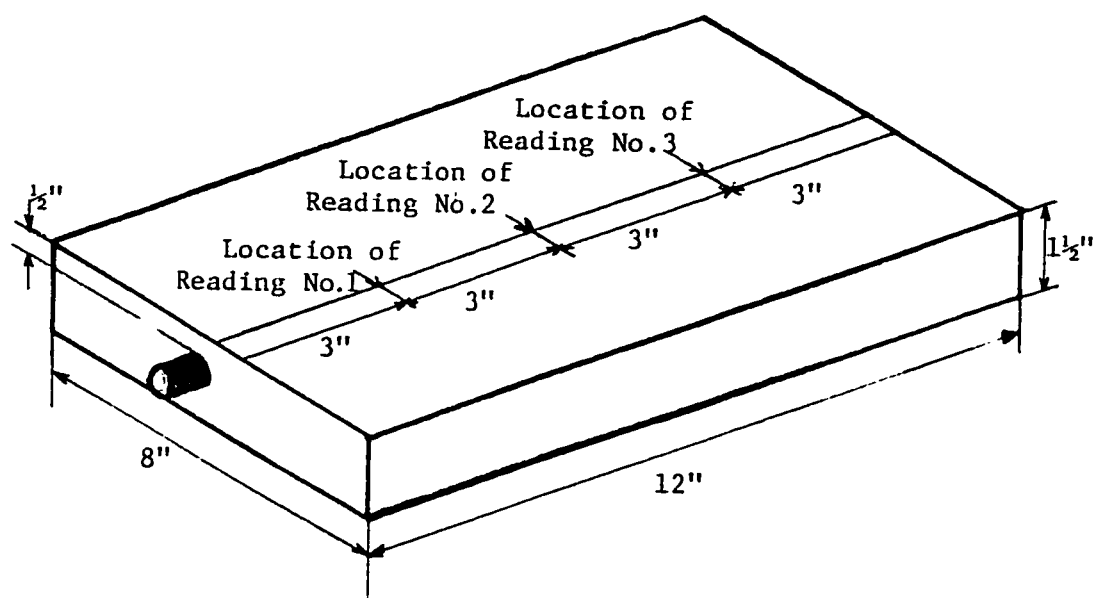
Fig. 4.11 : Laboratory slabs for monitoring corrosion by half cell device

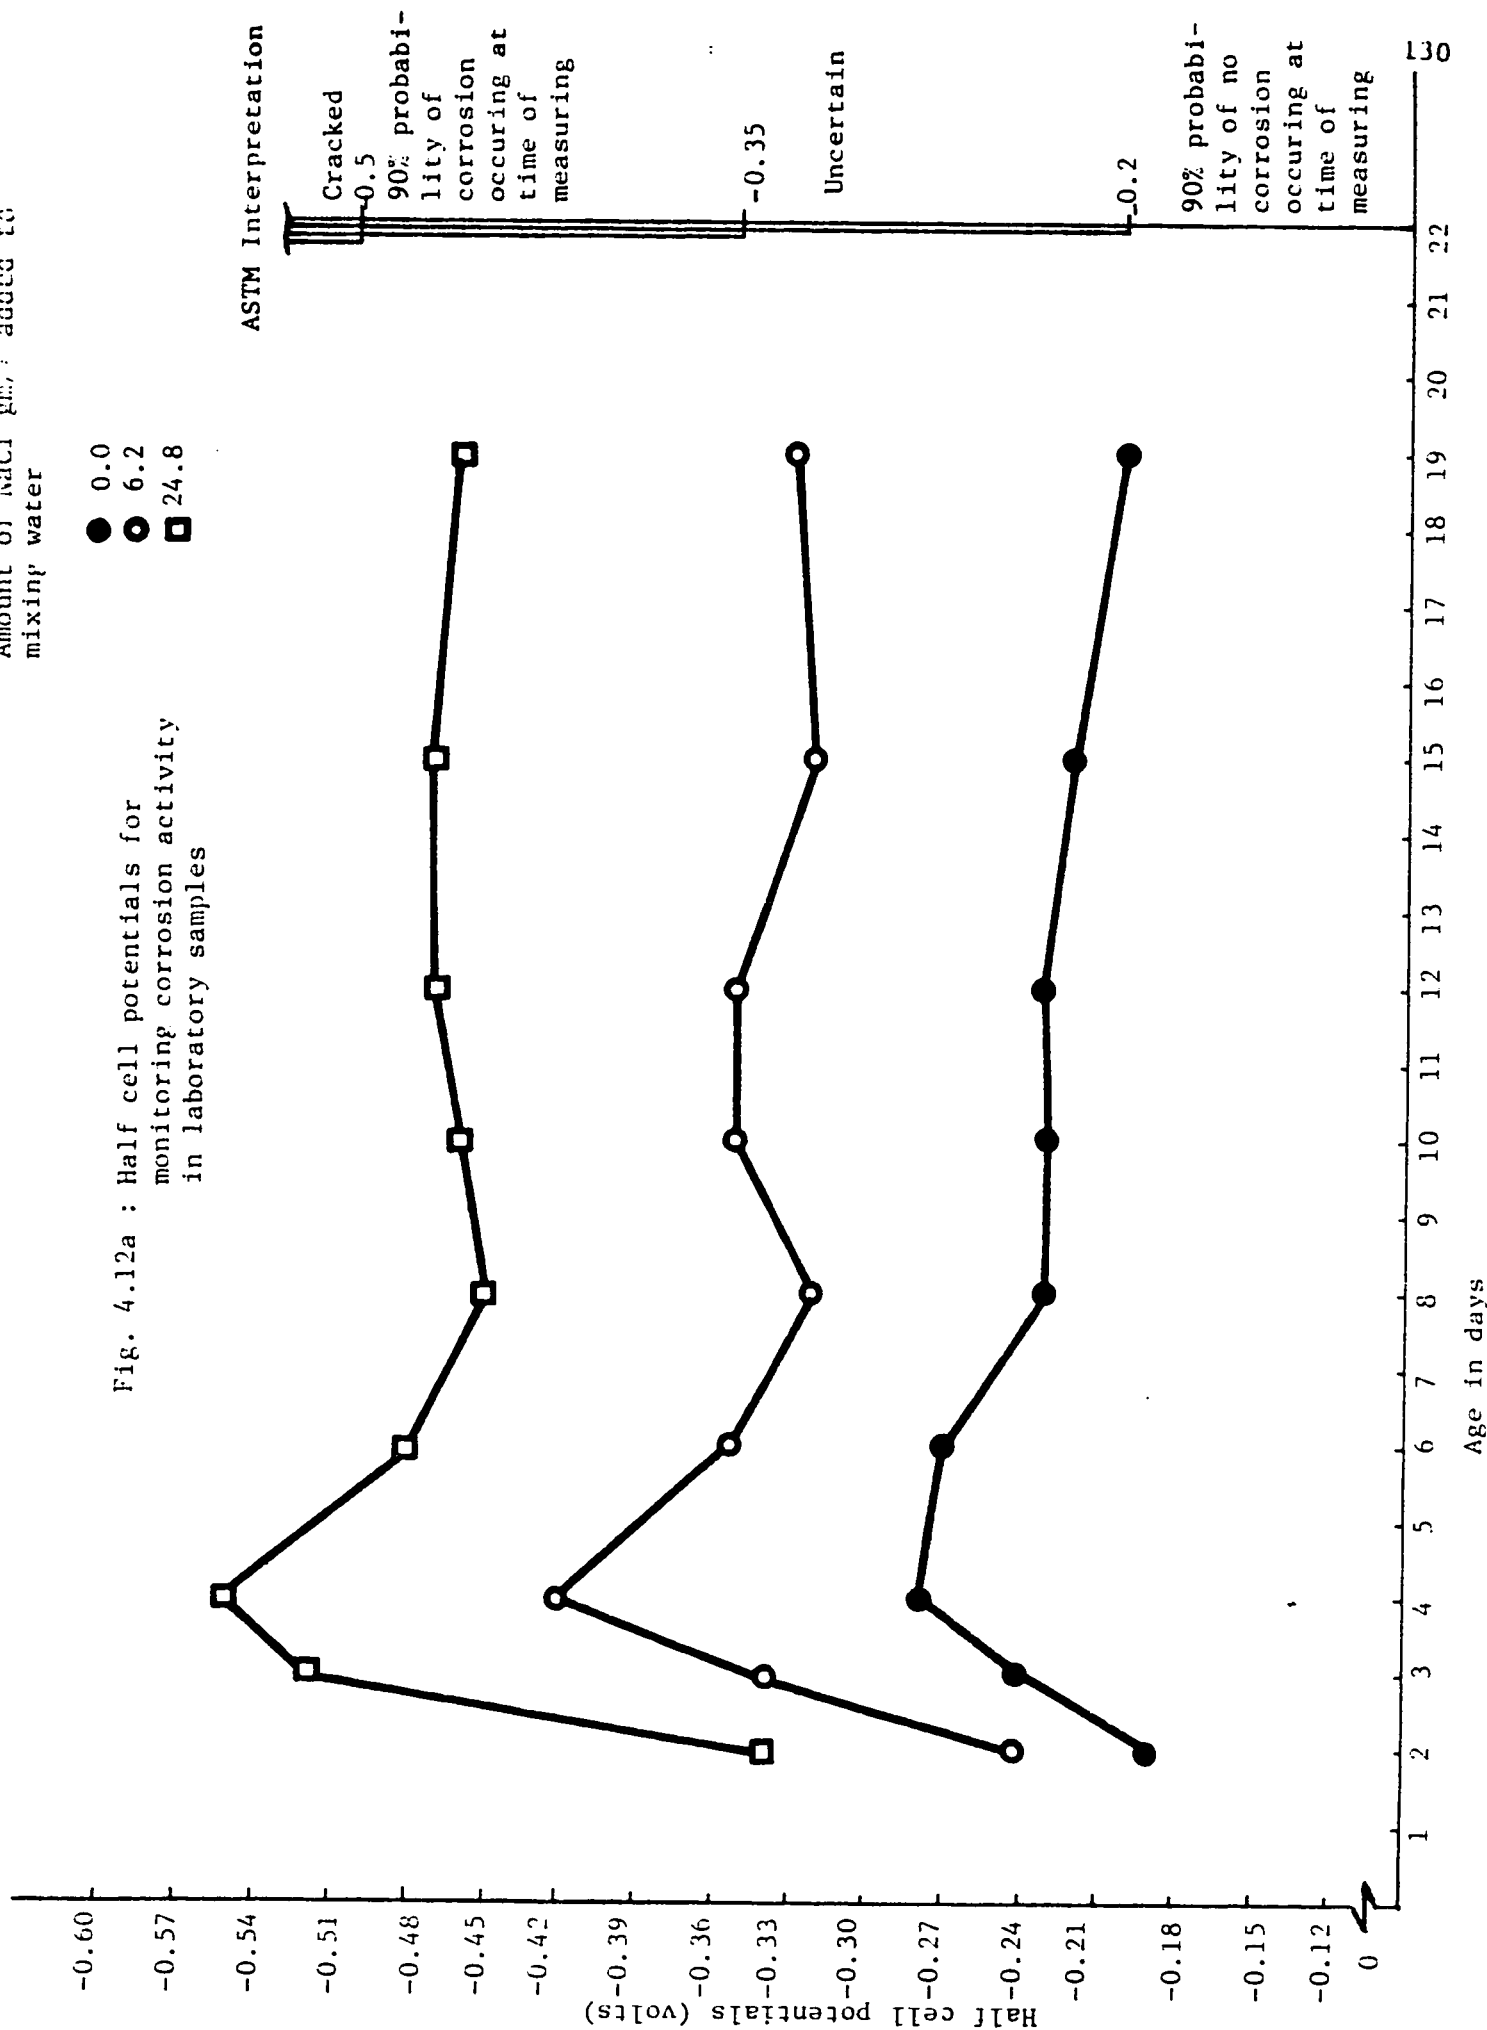
Fig. 4.12a : Half cell potentials for
monitoring corrosion activity
in laboratory samples

Figure 4.12 shows the half cell potentials plotted against time for the various aforesaid chloride concentrations. It is seen that the potentials increase showing an enhanced corrosion activity with the increase in chloride concentration. After 110 days of storage cores were obtained from the samples to observe the state of corrosion on the rebars. The observed state of the bars is described below and is also recorded in a sketched format on the right side of Figure 4.12b.

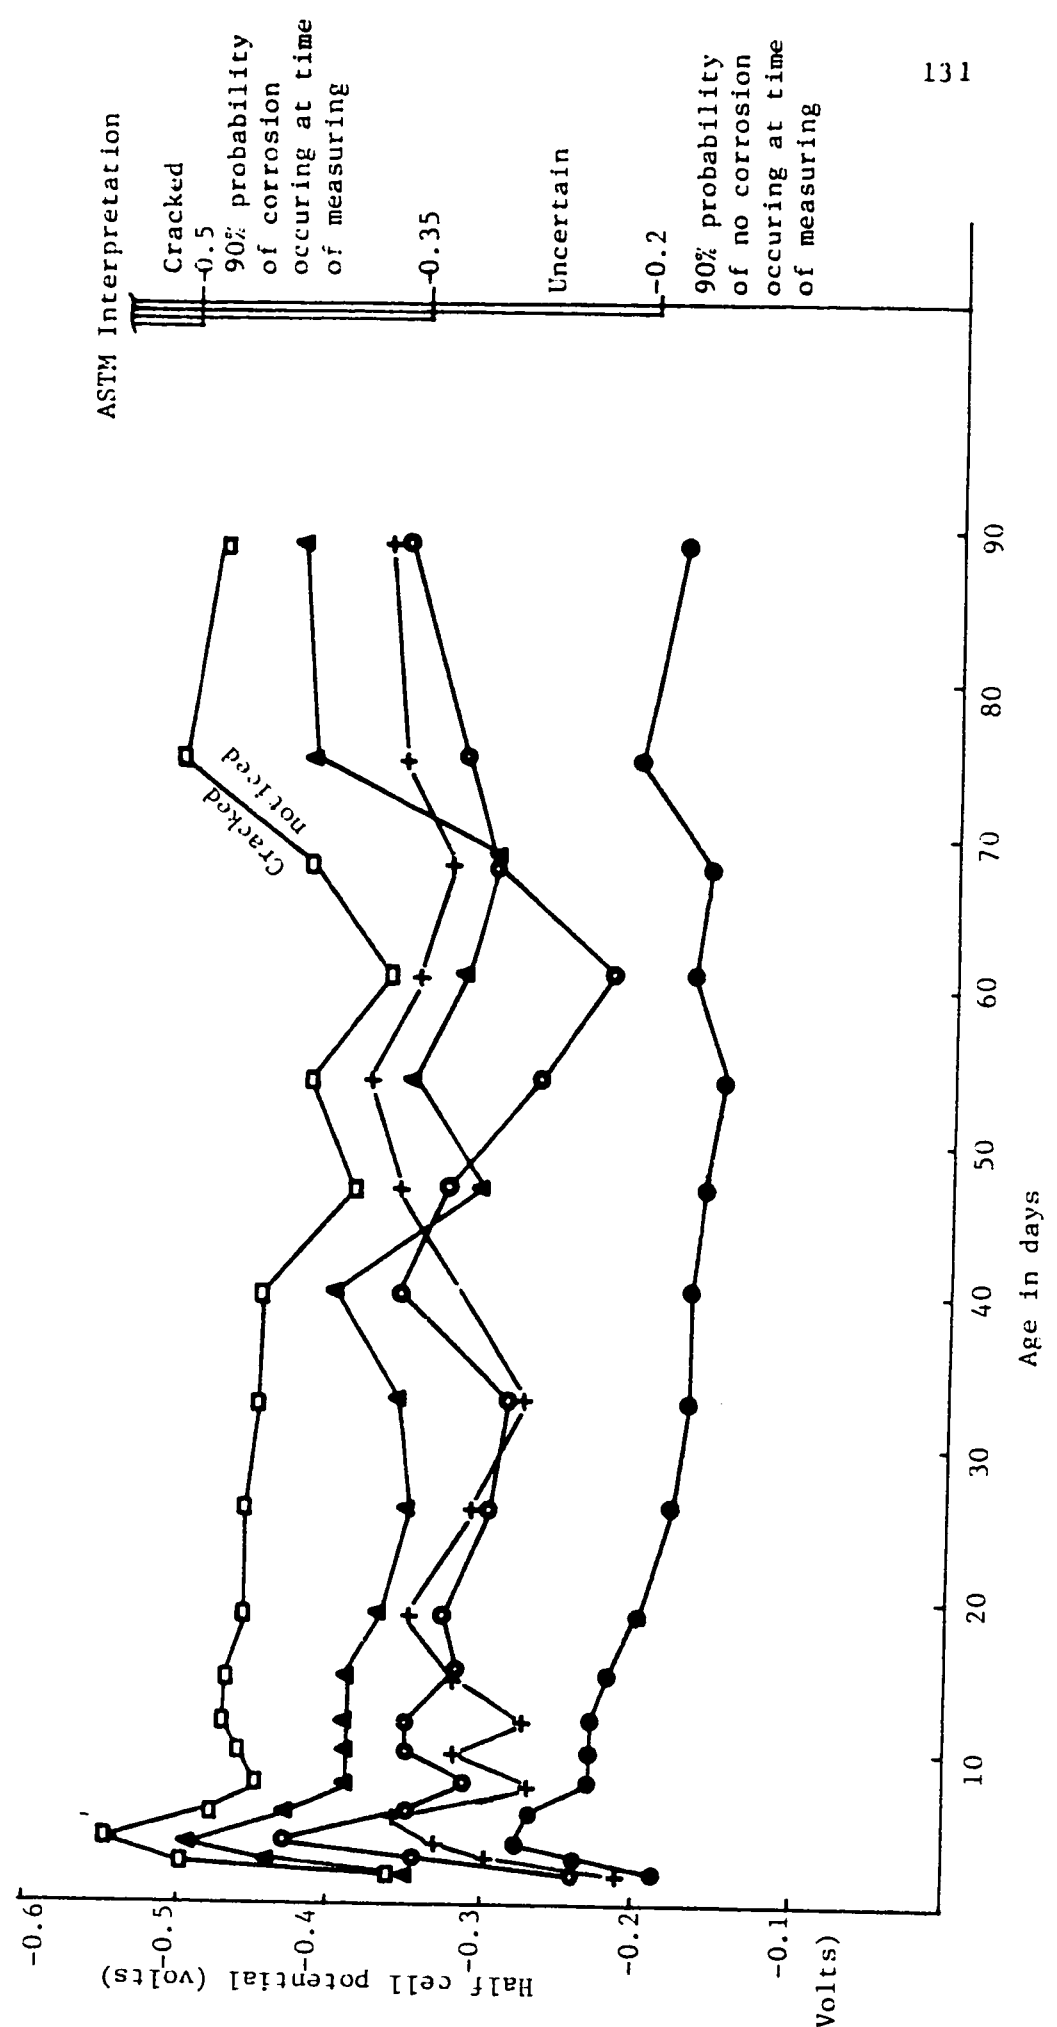
Fig. 4.12b : Half cell potentials for monitoring corrosion activity in laboratory samples

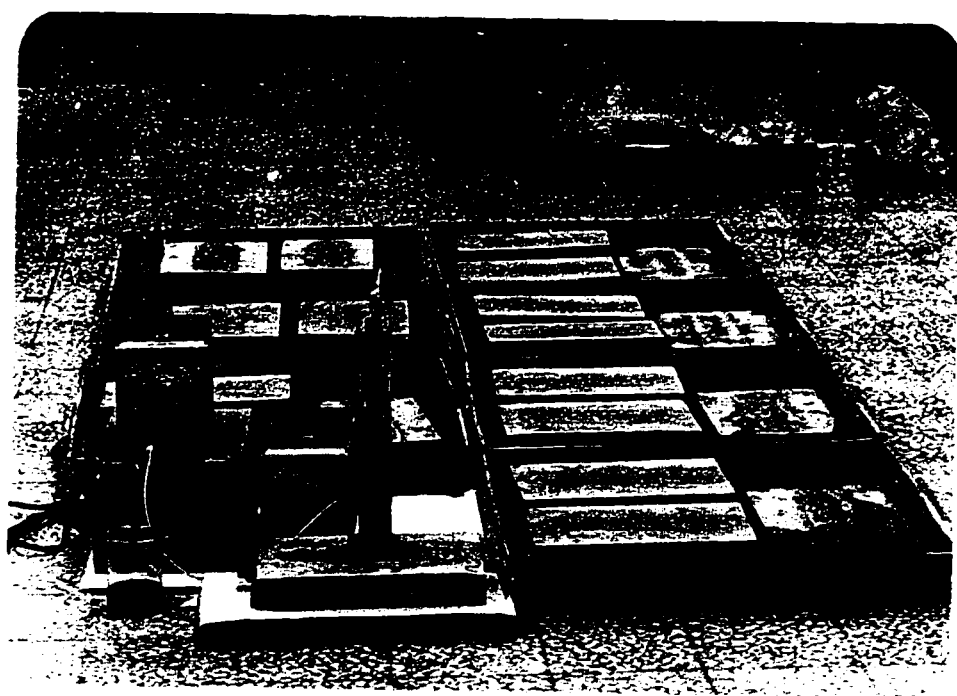
Plate 4.4 : Laboratory slabs for monitoring corrosion

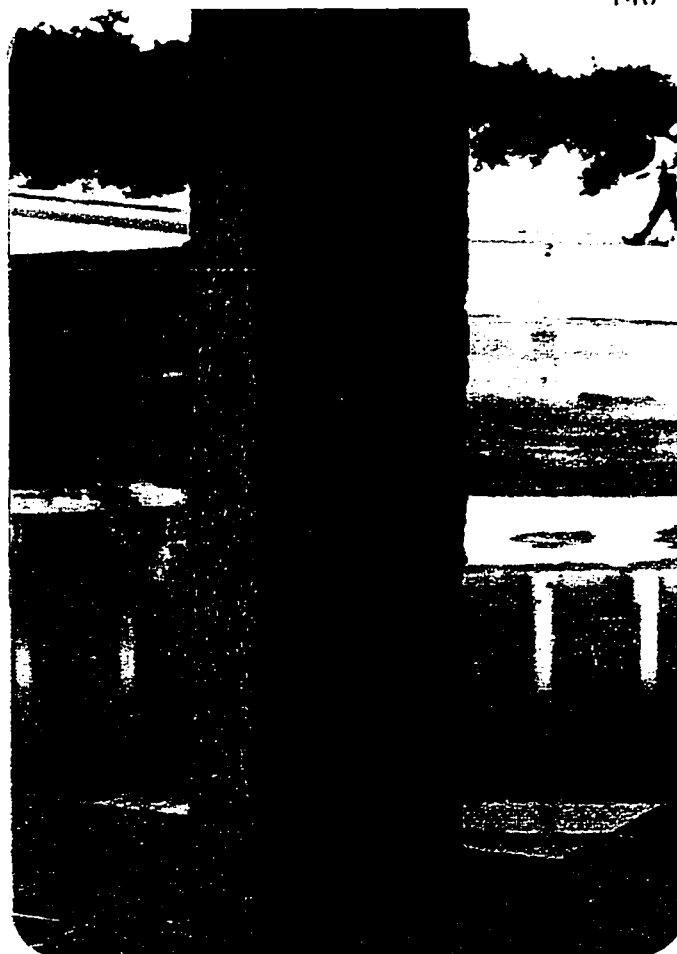
Plate 4.8 : Cracks developed at
higher level

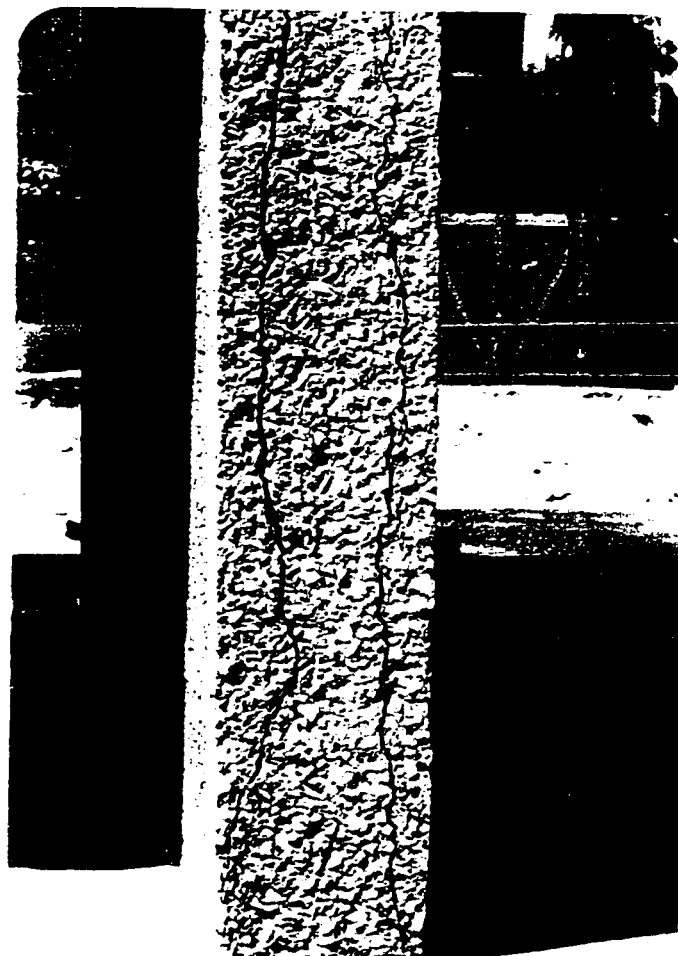
Plate 4.10: Longitudinal cracks in
column parallel to
reinforcement

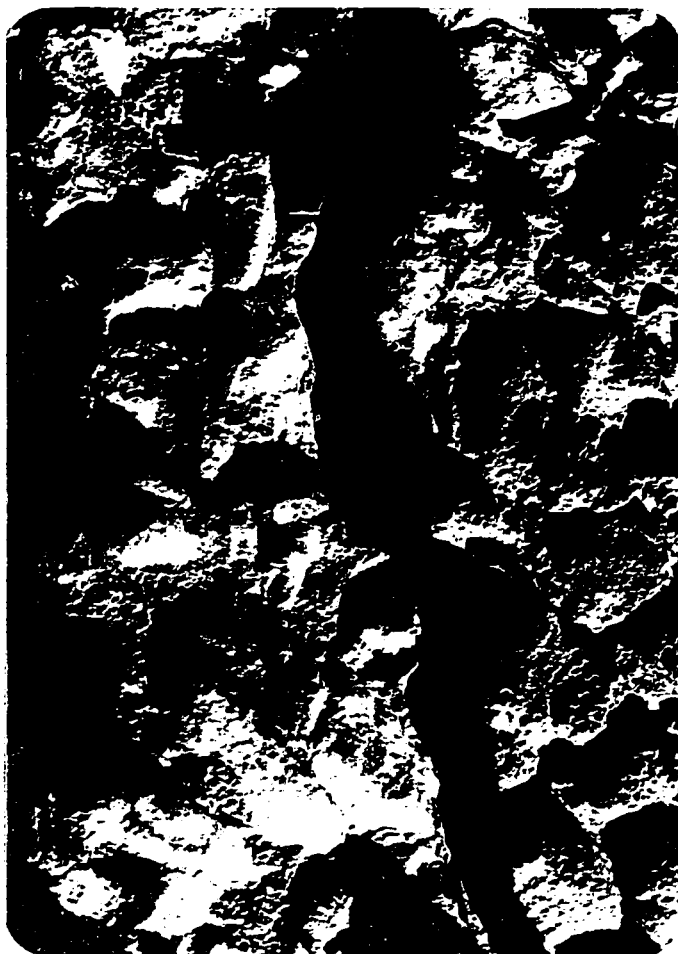
Plate 4.11 : Wide and deep crack along reinforcement

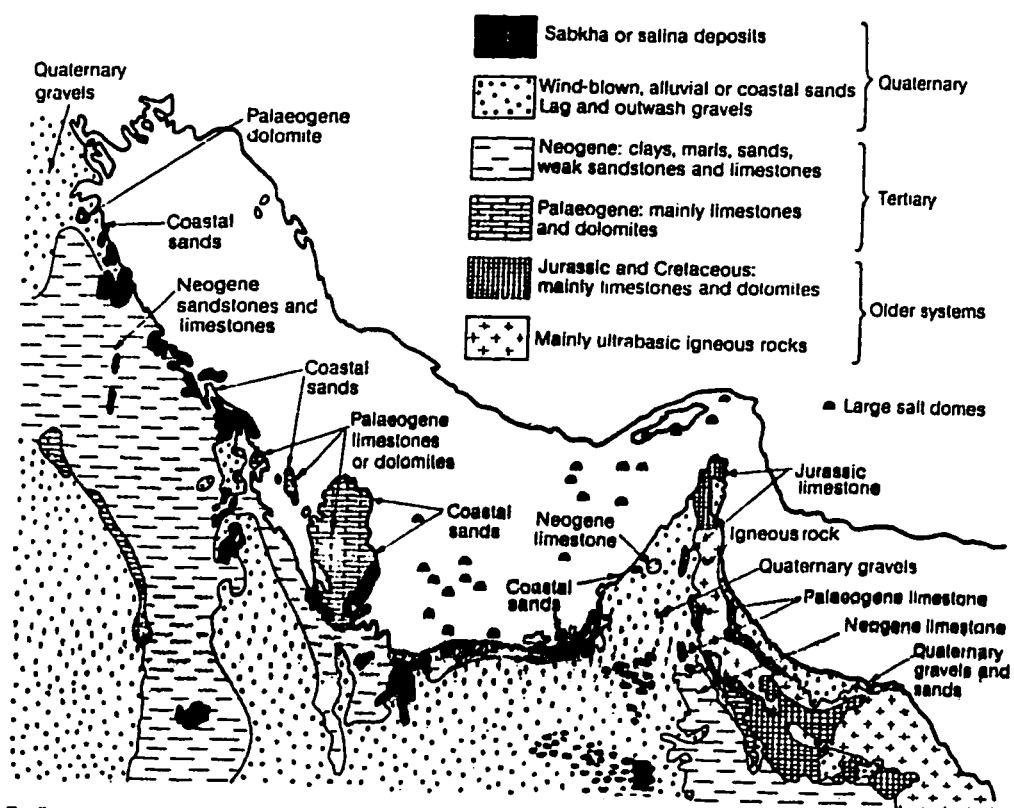
Fig. 5.2: Simplified geology of the Gulf States, with some important aggregate sources

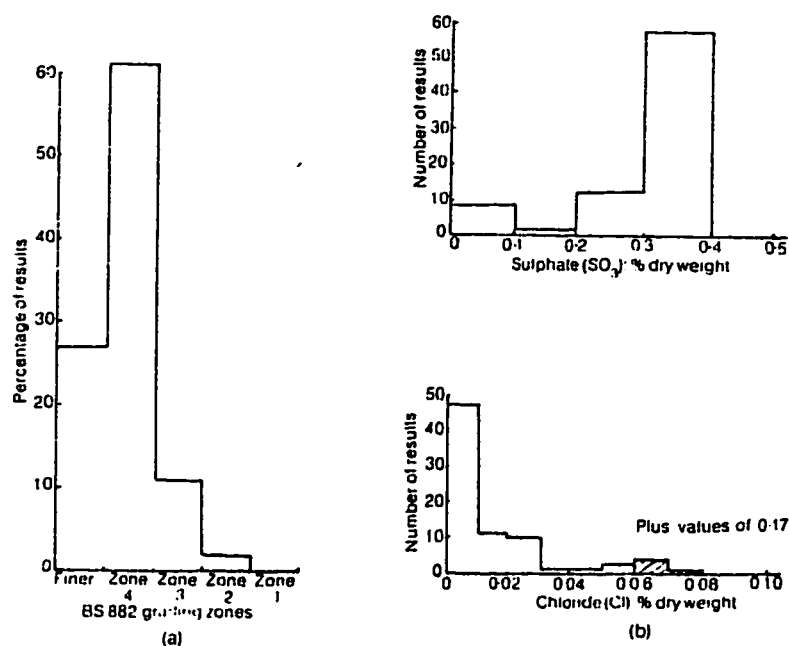
Fig. 5.3 : Some properties of Dubai sands:(a) beach sands-frequency distribution of gradings;(b) beach sands(from one typical section of beach) - frequency distribution of sulphate and chloride content; current working limits exceeded in hatched areas.

The beach sands usually have smooth rounded grains but may also be absorptive, trap air, chlorides and sulphates in their porous, sometimes hollow particles being of carbonate origin consisting of the worn debris of young marine organisms. However, the most serious drawback of the beach sands is their contamination to unacceptable chloride and sulphate levels. Table 5.5 shows an analysis of chloride contents for the Half Moon beach sand. In all the samples tested the level of contamination works out to be beyond the accepted limits.

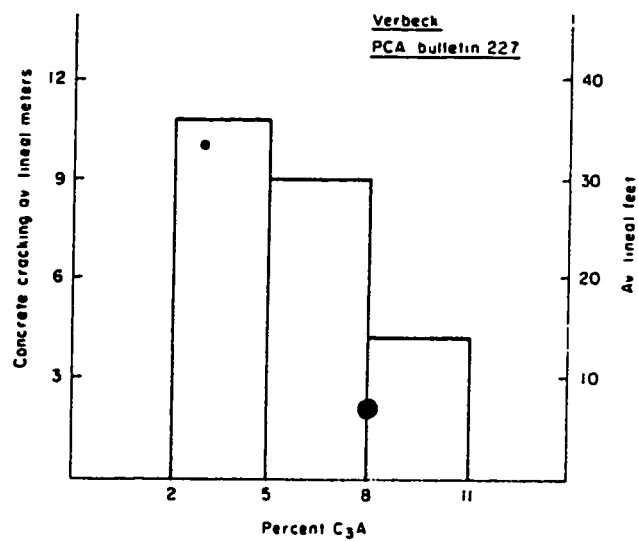
Fig. 5.7 : Effect of C_3A content on cracking of concrete due to steel corrosion.

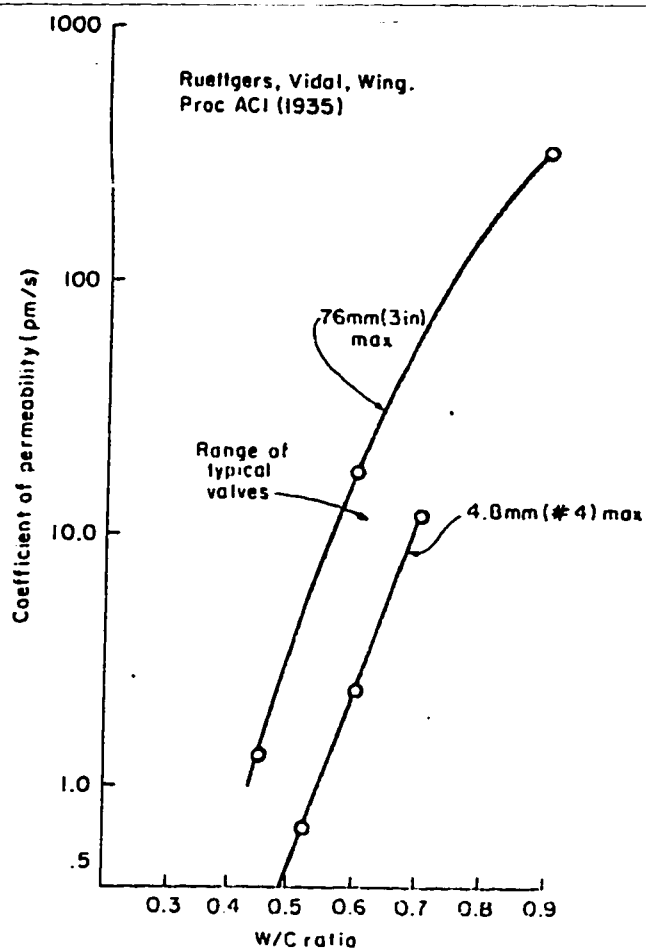
Fig. 5.9 : Permeability of concretes as influenced by w/c ratio.

Figure 5.9 shows the effect of w/c ratio on the permeability of concrete using 1/4 in. and 3 in. maximum size aggregates. Given sufficiently impermeable aggregate and a crack free matrix, the permeability of concrete is determined by the permeability of the paste phase, which can be reduced to extremely low values at w/c ratios below 0.4 (Figure 5.10). As deleterious ions such as Cl^- move through concrete by bulk flow and concentration diffusion, it is reasonable to assume that reduction in permeability will retard the progress of ions toward the steel, and hence increase the time necessary for initiation of corrosion. A similar barrier effect applies to the permeation of oxygen and moisture. Application of this concept can be seen in Figures 5.11a,b,c. Here 12 x 12 x 6 inch concrete slabs of varying w/c ratio having steel embedded at depths of 0.5 inch, 1 inch and 2 inches were subjected to a cycle consisting of 4 days ponding with a 3.5% NaCl solution followed by 10 days drying at 50% RH. The effect of w/c ratio is easily seen: Those slabs prepared at a w/c ratio of 0.6 exhibiting active corrosion much more rapidly than those prepared at a ratio of 0.45. Slabs prepared at the lowest w/c ratio (0.35) showed active corrosion (as measured by a sharp jump in the curve of potential vs time) only for

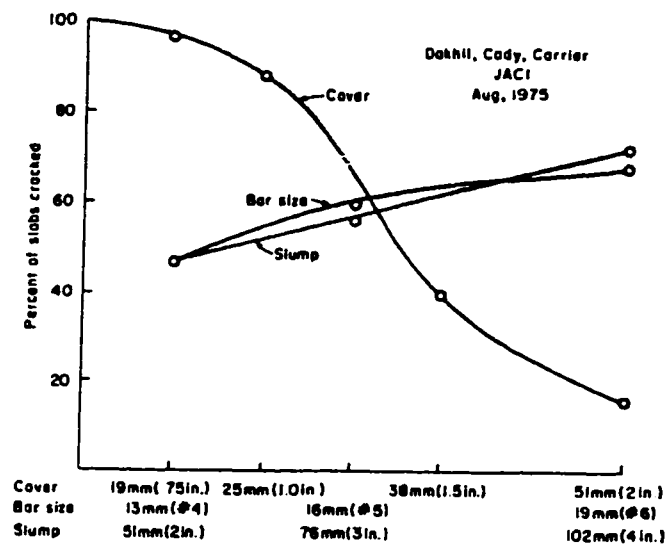
Fig. : 5.12- Cracking of concrete as influenced by cover, bar size, and slump.

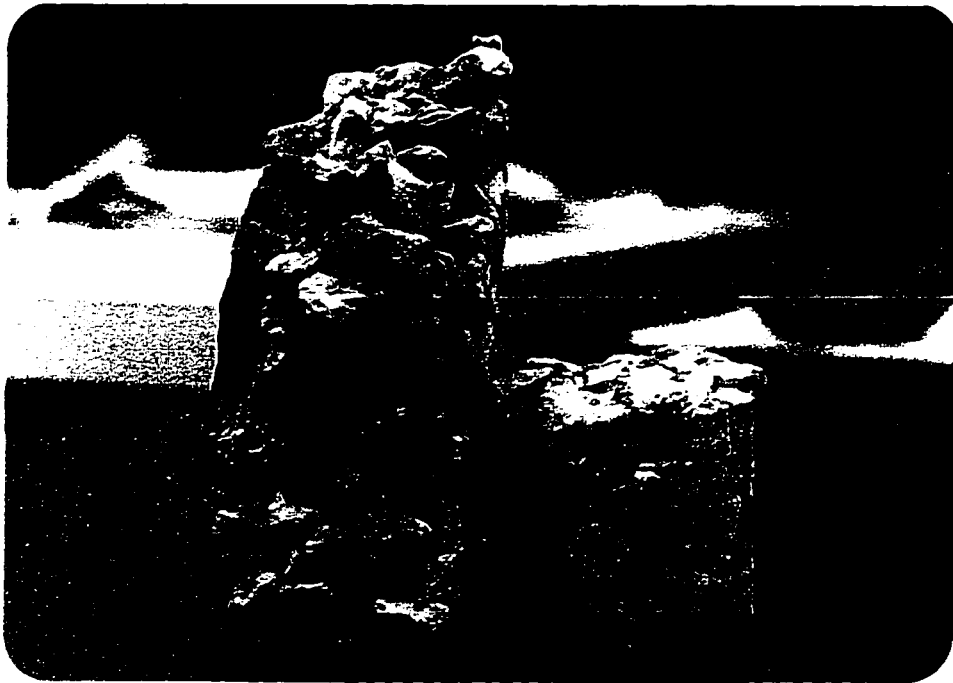
Plate 5.3 : Honey combed cover with thickness of 2.5"
