An Investigation of corrosion of steel reinforcement in concrete in the Eastern Province of Saudi Arabia

A Thesis Presented to the

KING FAHD UNIVERSITY OF PETROLEUM & MINERALS

February, 1981

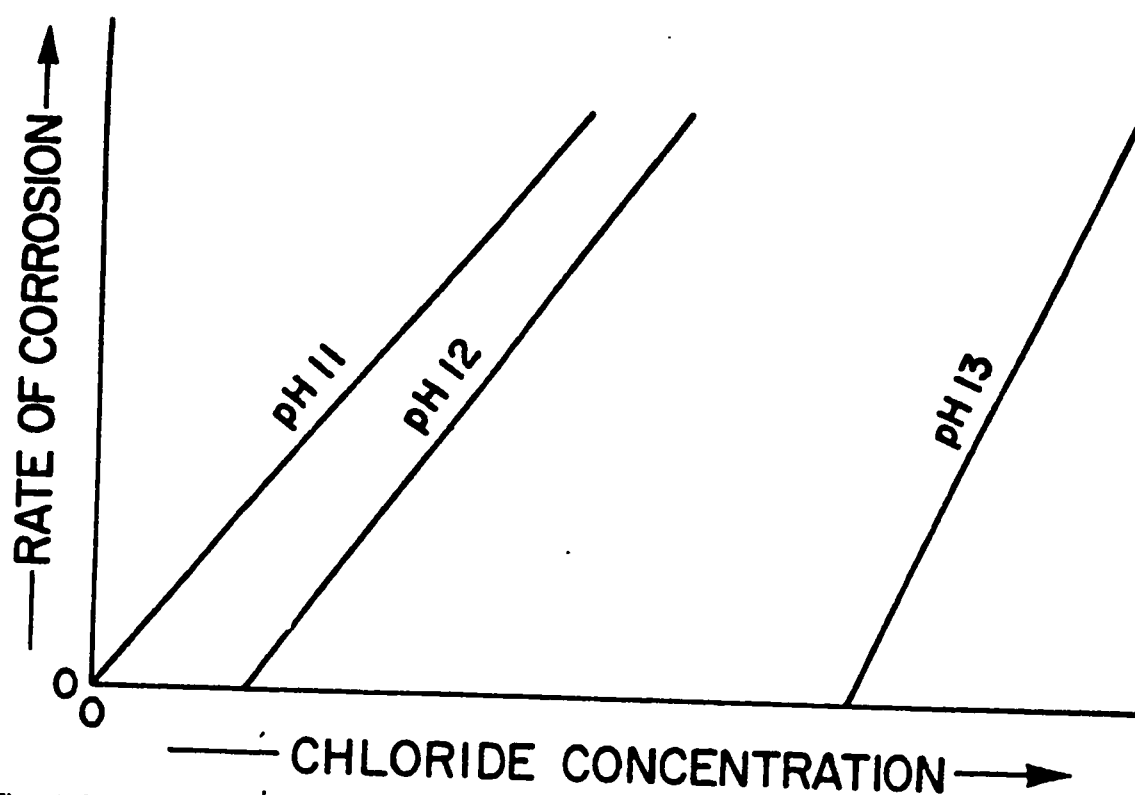
Fig. 6.2: Threshold chloride ion concentration required for corrosion to occur increases as the alkalinity, pH, of the cement paste liquid increases
