# **Evaluation of load transfer in axially loaded repaired concrete columns**

**Mohammed Hameeduddin**

Civil Engineering

May 2002

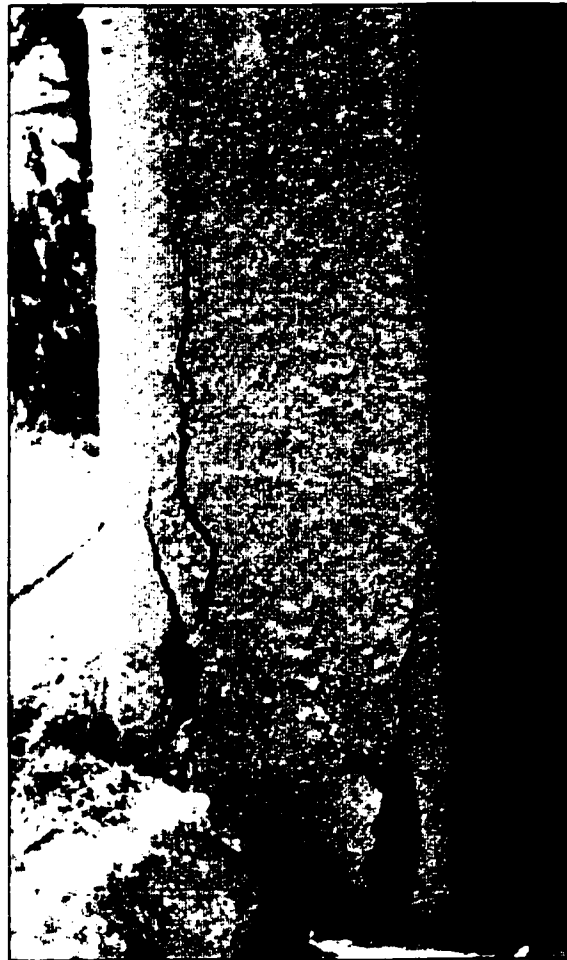
**Figure 1.1: Spalling of the Lower Portion of Column [Zoom-in view]**

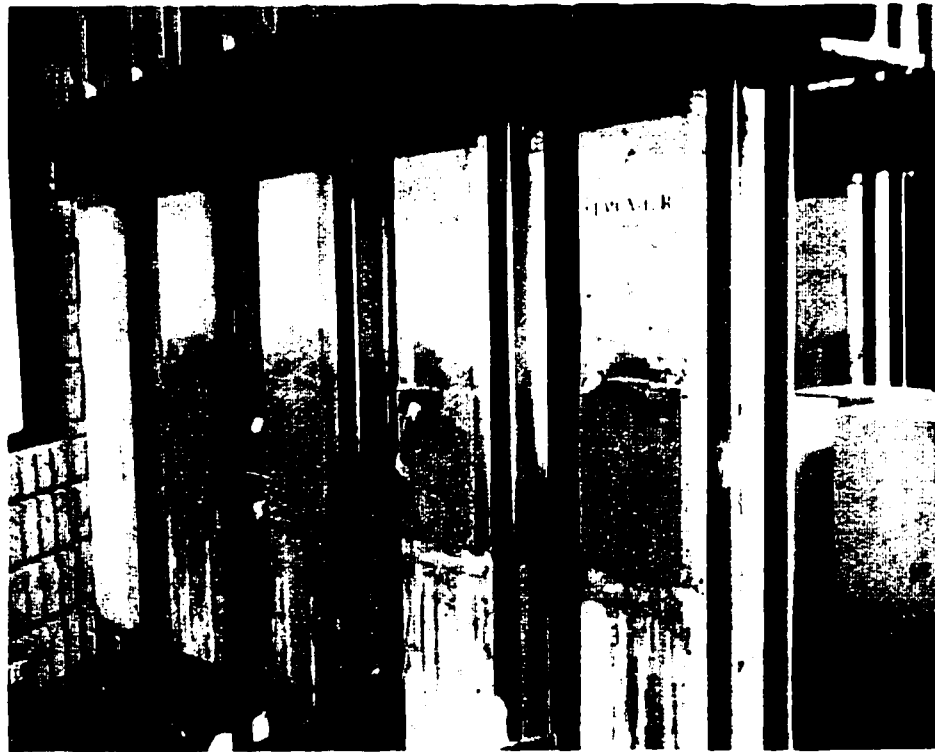
Figure 3.33: Test setup showing five columns in a creep rig under constant load

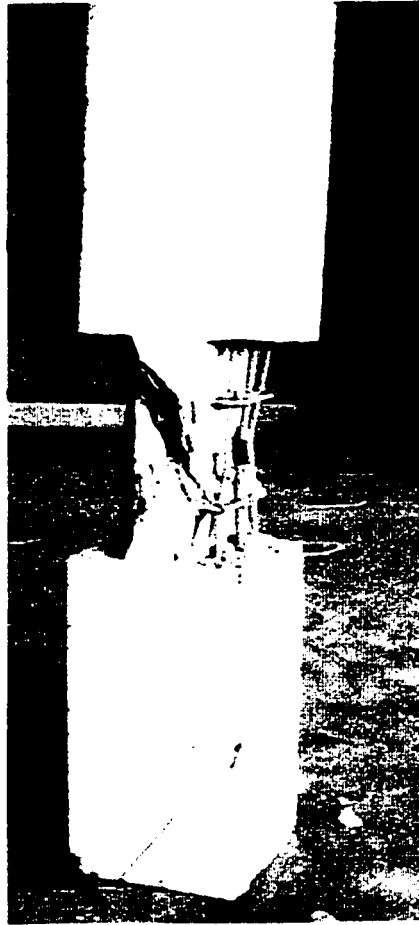
Figure 4.44: Failure of column specimen with recess

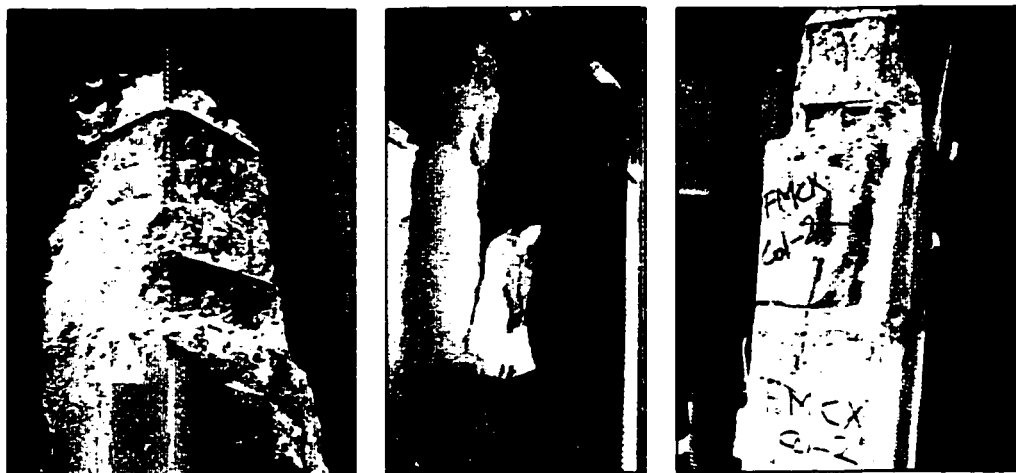
Figure 4.59: Close-up views of failure of column specimen repaired with FMCX
